Completion Report

Colonel James Barrett Farm

Period of Restoration - From July 2005 to December 2012

Report Date – November 2016

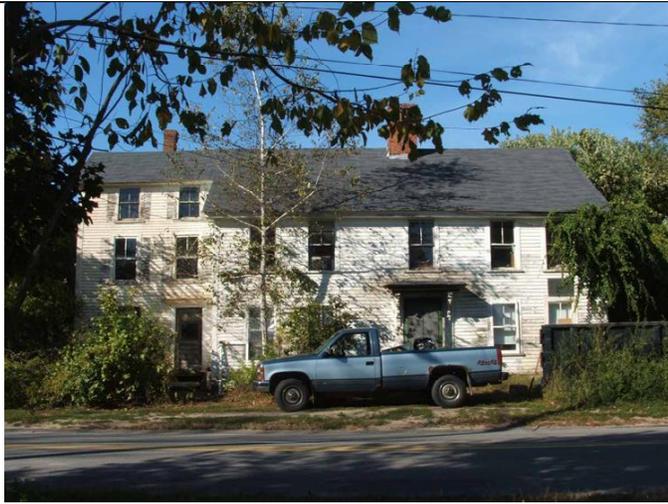
Before Restoration

The exterior had 20th century doors and windows, clapboards and trim installed ca. 1911. The severely rotted exterior roof sheathing was covered with 20th century asphalt shingles. The house was overgrown with invasives including bittersweet that was growing through attic windows. Chimney tops had been rebuilt in the 20th century and were also deteriorated. All visible exterior finishes had been installed during the 20th century and were considered unsalvageable except for front door and brackets that have been saved for future study and/or exhibit.

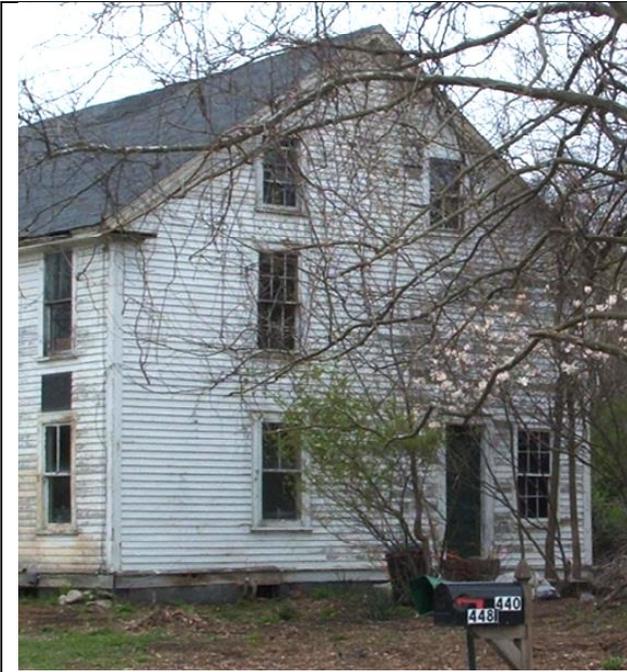
**Before Restoration**

The east end exterior had 20th century doors and windows, clapboards and trim installed ca. 1911. The 2nd floor rear of the former saltbox house had been added ca. 1810-1830. The partially rebuilt exterior sidewall sheathing was covered with late 20th century clapboards, door and window where the East Ell, altered in the 19th century, had been removed after its collapse ca.1977. All visible exterior finishes had been installed during the 20th century and were considered unsalvageable except for the ca. 1911 east entry door and cornice, found in the shed opposite, that have been saved for future study and exhibit. Cobble paving was found at East Entry area by archaeologists.

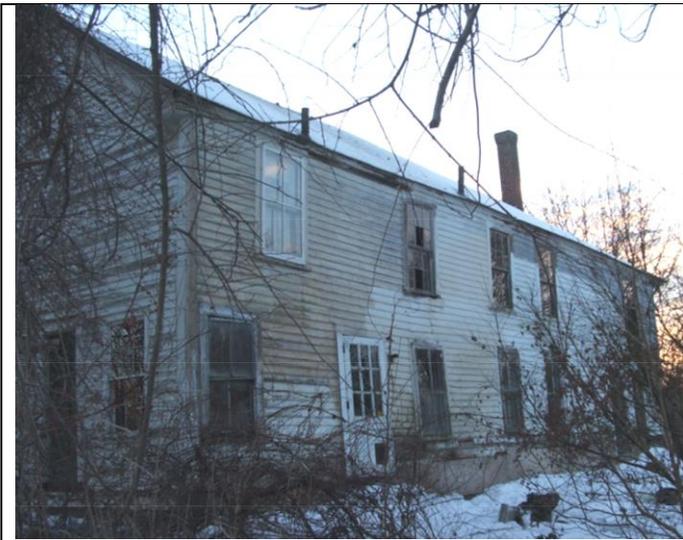
**Before Restoration**

The North, rear side of the house had 20th century doors, windows, clapboards and trim installed ca. 1911. The severely rotted exterior roof and sidewall sheathing was covered with 20th century asphalt shingles and clapboards from Fraser Mills in New Brunswick, NS. The house was overgrown with invasives, had severely rotted sills, and back wall with broken, rotted doors and windows. Chimney tops rebuilt in the 20th century\were also deteriorated. All visible exterior finishes had been installed during the 20th century and were considered unsalvageable except for sample components\ saved for study and/or exhibit.

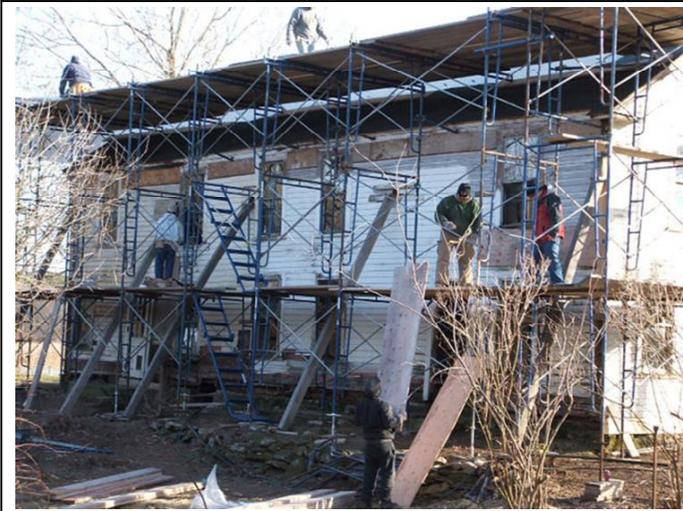
**During Restoration**

The main house rear wall was hanging from the roof rafters and needed emergency shoring. Staging was set up to remove the asphalt shingle roof and rotted sheathing, replaced with white pine one inch boards matching originals. 20th century clapboards were removed and unsound sidewall sheathing and framing replaced where necessary. Tyvek was used as a temporary covering. 20th century windows were removed. Remnants of First Period framing, re-used in the building of the lean-to ca. 1768, were preserved and retained in situ or re-installed where found. White oak was used for the 18th c. one story lean-to and white pine for ca. 1810s 2nd floor addition.

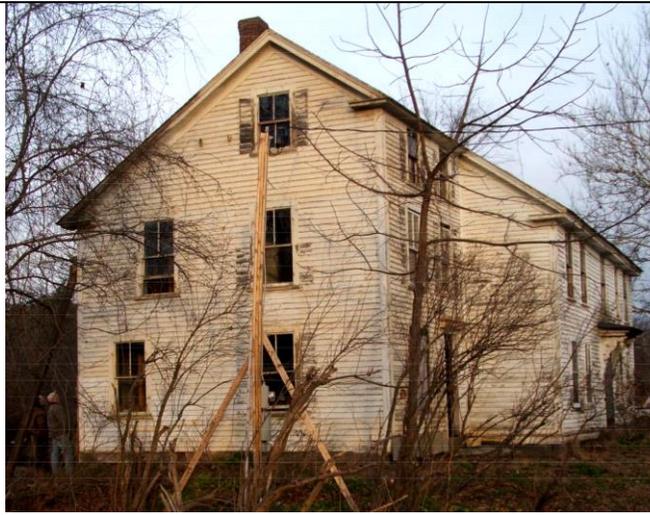
Before Restoration

The exterior had all 20th century doors and windows, clapboards and trim installed ca. 1911. The deteriorated exterior roof sheathing was covered with 20th century asphalt shingles. The house was overgrown with invasives and volunteer sapling trees. The West Ell brick stove chimney, built in 1911, was unstable. All visible exterior finishes had been installed during the 20th century and were considered unsalvageable except for some door, window and trim components saved for future study and/or exhibit. All utility systems had failed or were obsolete and dangerous so temporary electrical and water services were installed to allow work to proceed.

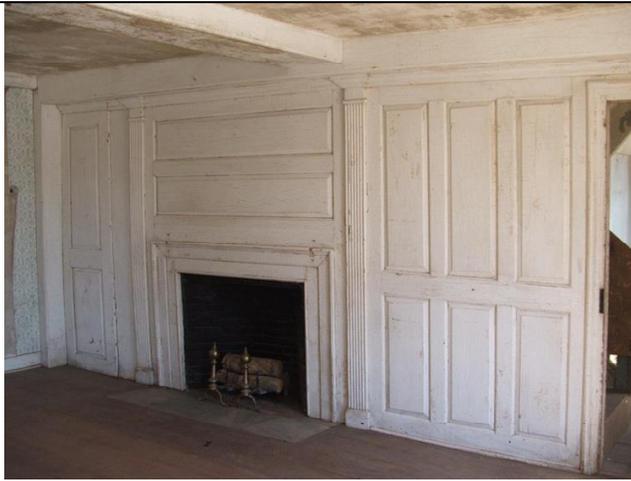
**Before Restoration**

The parlor as found retained all its original woodwork dating to the 18th century. The pilaster and panels all probably date to Col. Barrett's rebuilding of ca. 1768. The fireplace architrave surround and panels to the left were added later in the 18th century, but possibly during the Colonel's lifetime. Evidence was found for a former corner cupboard similar if not identical with one from the Thomas Barrett House at Barrett's Mill, now in the Concord Museum. The accumulation of lead paint made it necessary to remove most of the overlying layers to meet safety and health codes.

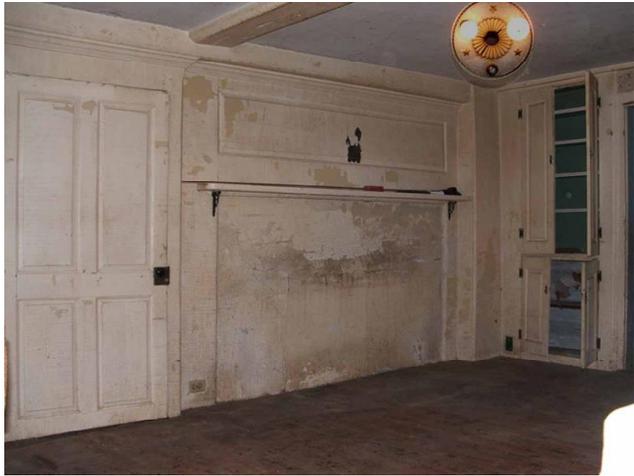
<p>Before Restoration</p> <p>The Muster Room as found retained all its original woodwork dating to the 18th century. The doors and woodwork all probably pre-date Col. Barrett's rebuilding of the house ca. 1768. The china cupboard to the right of the fireplace, and shelves in the china closet to the left, were added later in the 18th century, but likely during the Colonel's lifetime. The plaster ceiling in place was 20th century, dating to the time of electric light installation, seen hanging from the summer beam. It replaced an earlier 18th century plaster ceiling undoubtedly added over planed and chamfered joists during Col. Barrett's lifetime. Flaking later lead paint required removal of most overlying paint layers to meet safety and health codes.</p>

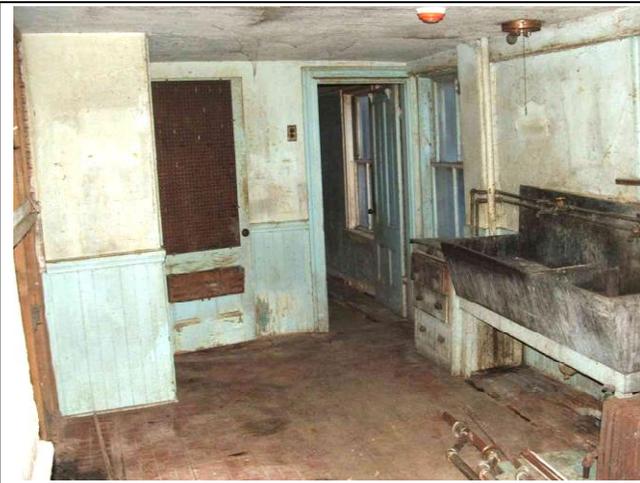
**Before Restoration**

As found, the Kitchen south partition and exterior wall had 20th century plaster on walls and ceilings with bead board dado. The severely rotted floor was covered with 20th century linoleum. The north exterior wall had a large, 20th century double soapstone sink, dating to the McGrath period renovations. This had to be removed for structural repairs to the floor and exterior wall that had previously been rebuilt in the 19th century and again in the early 20th century. A closet had been installed in the southwest corner of the kitchen along with all visible finishes that had been installed during the 20th century McGrath renovations that included plumbing and electrical.

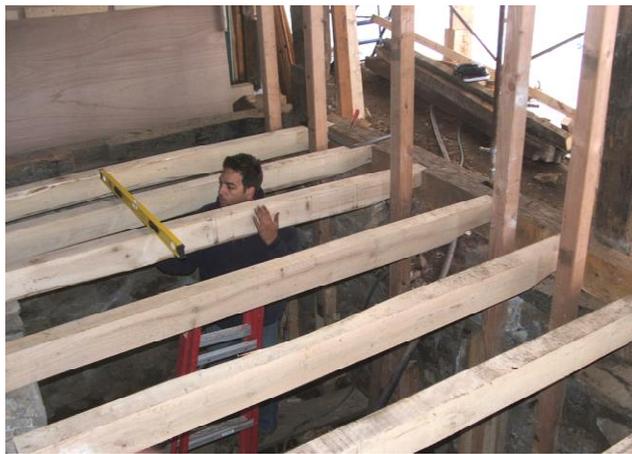
**During Restoration**

The Kitchen after removal of 20th century flooring, wood dado, trim and plaster on walls and ceilings revealed rotten mostly 19th century replacement joists. These were so rotted they had to be replaced in kind by timber framers matching the original framing layout. On the West partition, removal of plaster revealed 18th century feather-edge board sheathing. The badly rotted floor was re-framed with oak joists overlaid by wide pine sub-floor and finish floors similar to originals. Some post and beam casings remained with others reproduced and stained to match. The 18th century batten doors were reproduced to match originals; one remained in poor condition, but was retained for exhibit.

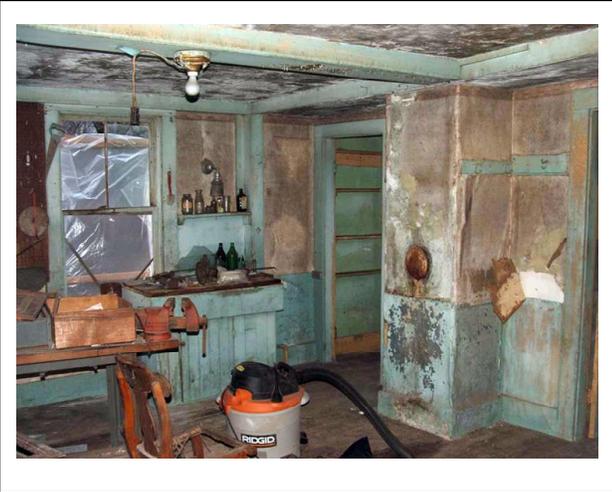
<p>Before Restoration</p> <p>The West Ell Front Room (view NW) as found retained little original woodwork dating to the 18th century. The post and beam casings, the framing and almost all plaster, except the chimney wall, date to Col. Barrett's rebuilding addition of the West Ell ca. 1768. The former large (8-foot hearth) kitchen fireplace and associated paneling of the partition and chimney dating to Col. Barrett's lifetime were likely removed when the McGraths installed a stove flue inscribed upstairs "Built April, 1911." The dry sink and shelving were added around that time the house was renovated. The accumulation of peeling lead paint made it necessary to remove most of the overlying layers and electric wiring to meet modern code.</p>

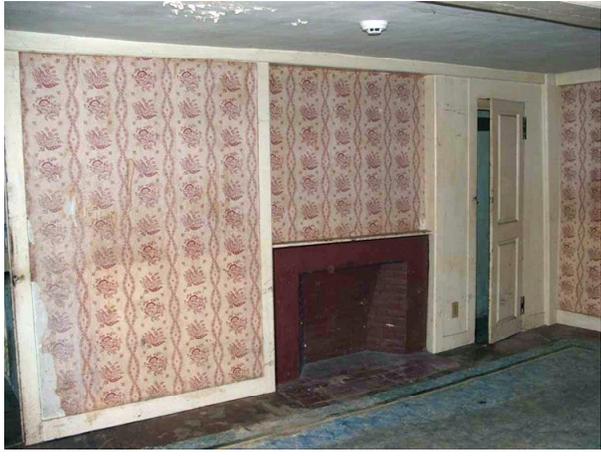
<p>Before Restoration</p> <p>The East Chamber as found retained most of its original woodwork dating to the 18th century. The plaster, doors and trim all probably date to Col. Barrett's rebuilding of ca. 1768. The fireplace architrave surround probably a bolection molding similar to that of the West Chamber, was removed when the fireplace was rebuilt in the early 19th century. The present Rumford firebox with its wider hearth and red-painted plaster parging are all typical of the period ca. 1810s to 1830s when the Kitchen fireplace and oven were also rebuilt. The floor covering is a 20th century McGrath addition. The layers of lead paint were peeling and removal of later layers was required to meet code.</p>

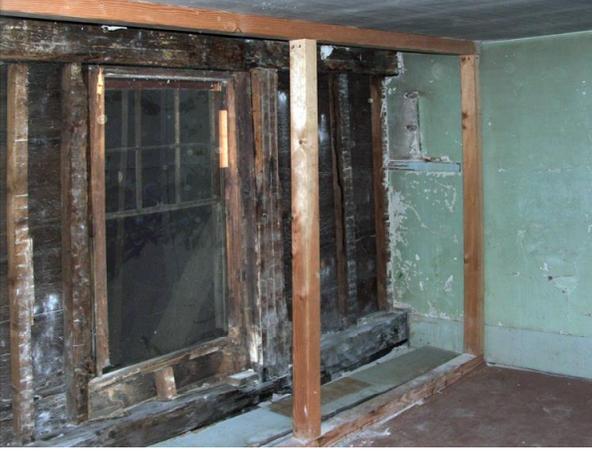
<p>During Restoration</p> <p>The Kitchen Chamber interior had overlying 20th century plaster removed for structural repairs revealing various re-used 18th century framing components in the rebuilt exterior wall. Framing evidence showed that window openings were originally the same scale as those of the front of the house built in the 18th century. Ceiling (attic floor) framing and wall plates of the original saltbox (below the window sill) and the later 19th century roof plate above were rotted beyond repair. However, original floorboards, re-used early 19th century posts, beams, and boards of the Federal Period were preserved and restored to their former locations. The 20th century partitions had to be removed in order to repair framing.</p>

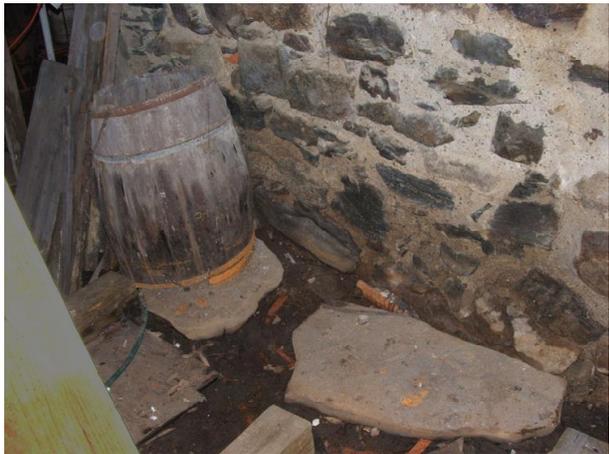
<p>During Restoration</p> <p>The North cellar interior (004 View NE) had large stones by the chimney wall with one severely rotted 20th century barrel remaining in situ on the stone paving. The chimney base had a cast iron door on an ash cleanout for the kitchen fireplace that had to be removed in the course of rebuilding to support the first floor joists. The Northeast corner of the chimney base had to be rebuilt as did the area around the niche where the brick furnace flue extended through the Muster Room fireplace. There was evidence of a board partition at the corner of the chimney base extending to the North exterior wall. A 19th century batten door from the partition and a badly decayed 18th c. batten door and hardware, believed to be that from the kitchen stair, were found lying about.</p>

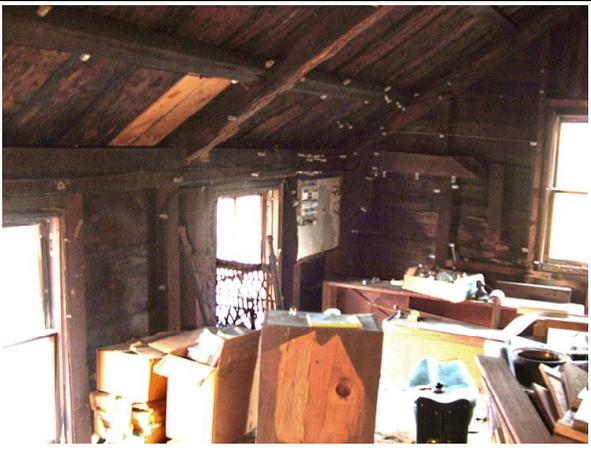
<p>Before Restoration</p> <p>The West Ell Attic interior (Area 308 View West) as found retained all its original framing, flooring, and most sheathing dating to the 18th century. However, much of the roof sheathing was severely deteriorated and was not capable of carrying snow or wind loads with inadequate nailing for any new roofing. Exterior windows had been changed ca. 1911 and the existing windows were too deteriorated to salvage. The attic floor was filled with McGrath era items that were for the most part removed by the former owners. What remained was cleaned out with the exception of some late Barrett and early McGrath papers that were placed in archival storage with artifacts.</p>

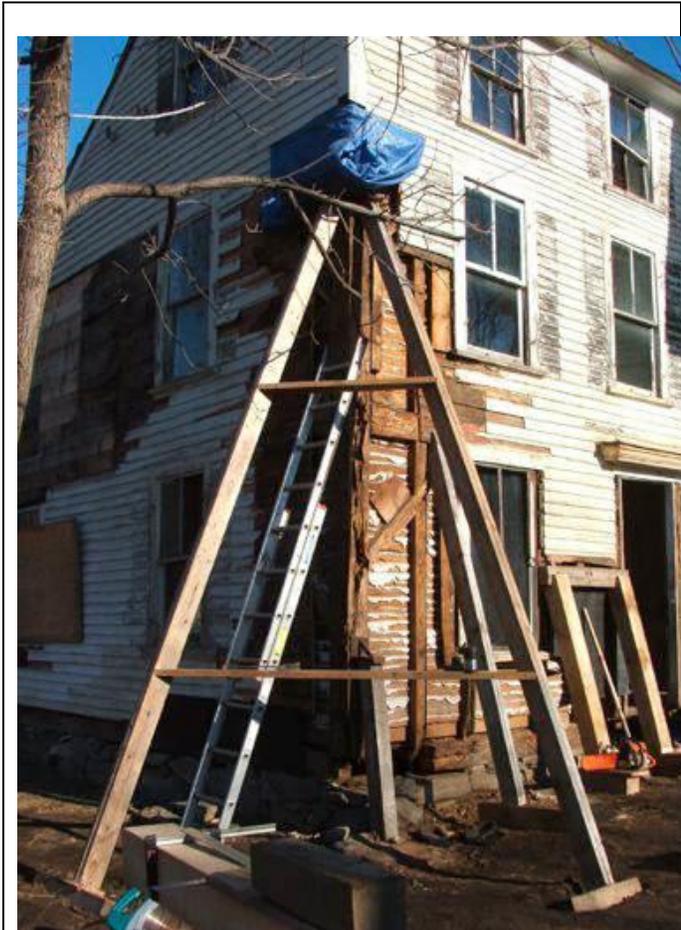
Figure 16 The West Ell NE Corner Post
Was found to be severely deteriorated and needed shoring for repair.

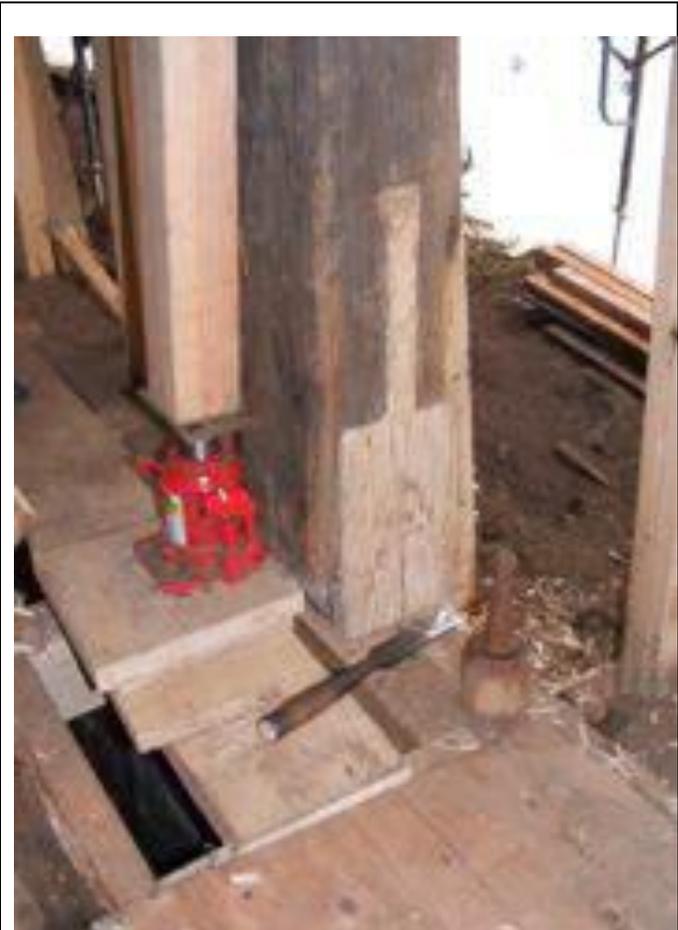
Figure 17 Kitchen Post Base
Extensive and careful labor and craftsmanship was required to preserve and repair the base

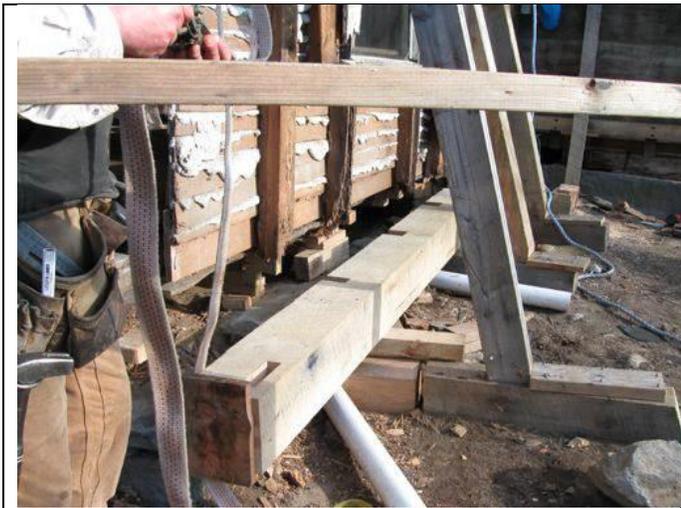
Figure 18 The Rear Sill
Was entirely decayed and had to be exactly reproduced of oak to match original.

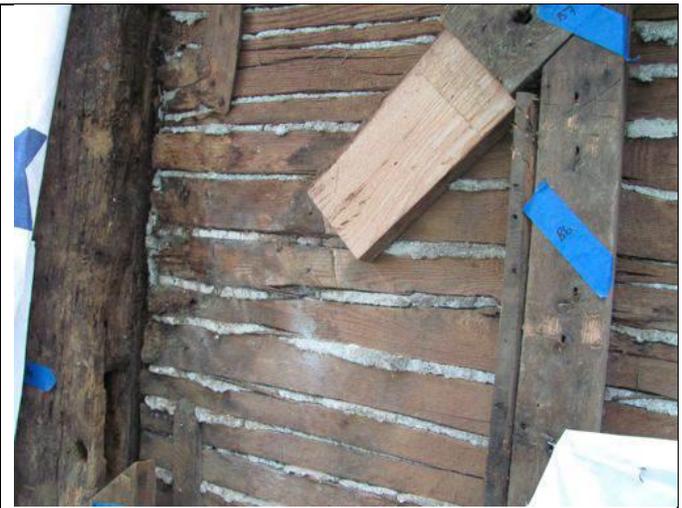
Figure 19 SE Corner Post Brace
A post brace at the SE corner had to be spliced with a lapped joint,

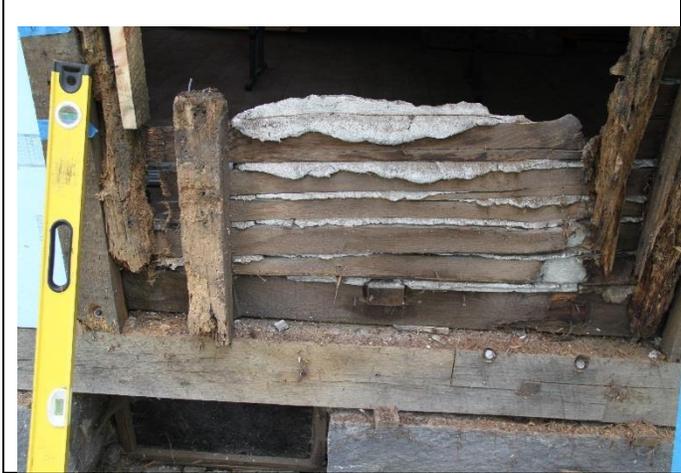
Figure 26 Muster Room Wall Repairs Needed

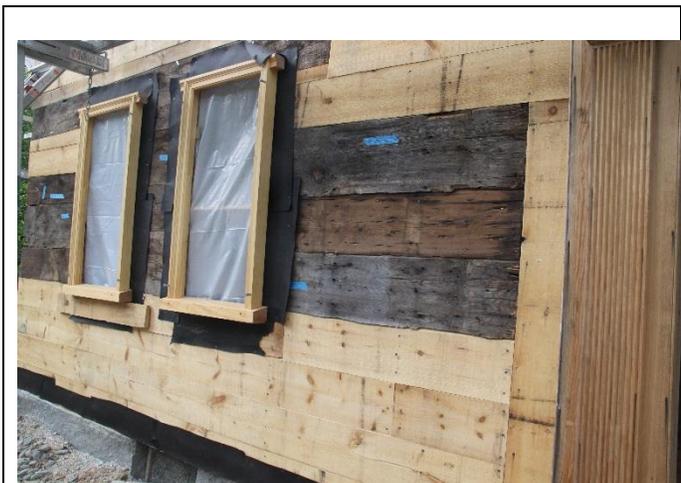
Figure 28 Old and New Sheathing
Old sheathing was retained where still capable of holding nails.

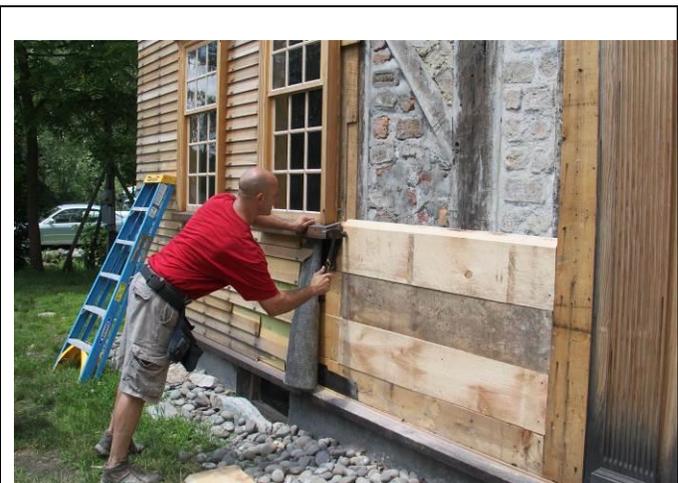
Figure 29 Exterior Siding
South exterior showing a repair to the nogging (brick), the structure, Home Slicker, sheathing, and clapboards.

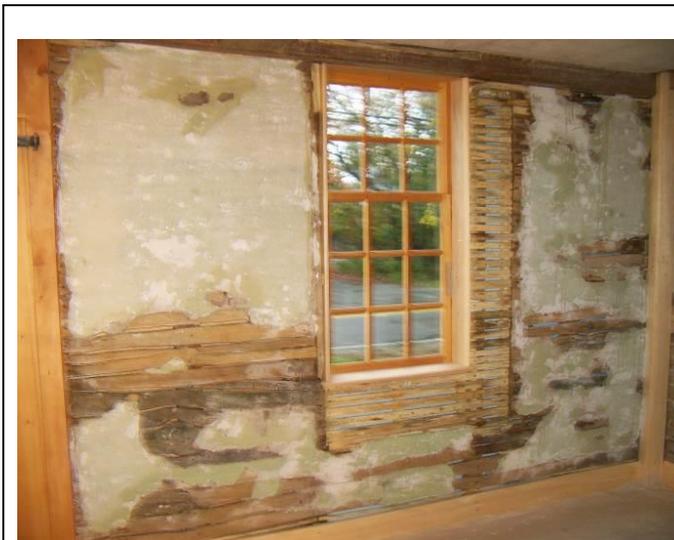
Figure 38 Plaster – West Ell - South wall
After adhesive injection

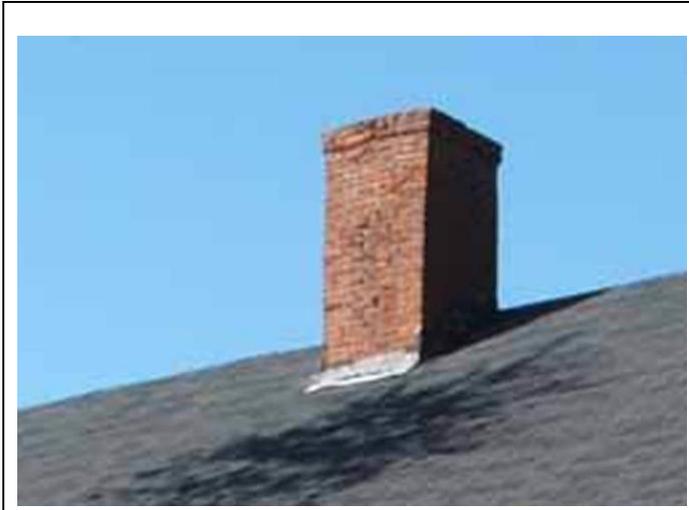
Figure 68 Chimney Pre-Rebuild
 The main house chimney prior to restoration was cracked, unstable, and had to be removed to the roofline. It had been rebuilt smaller in the 19th century.

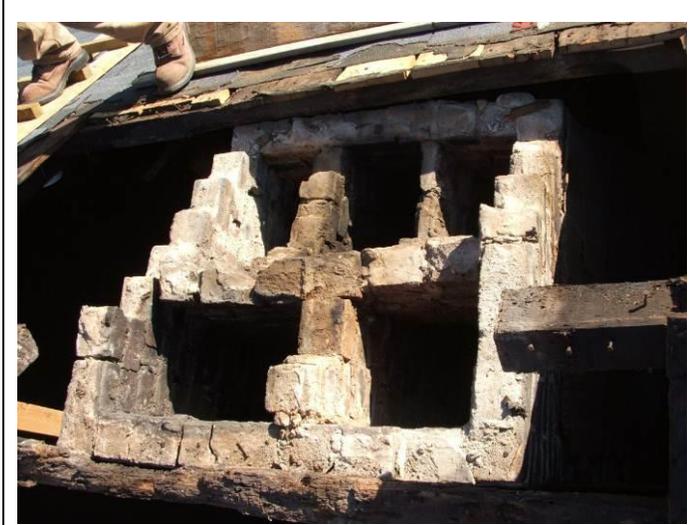
Figure 70 Chimney Flues
 The original five flues of the main house chimney as found had undergone severe erosion and deterioration down to the roofline.

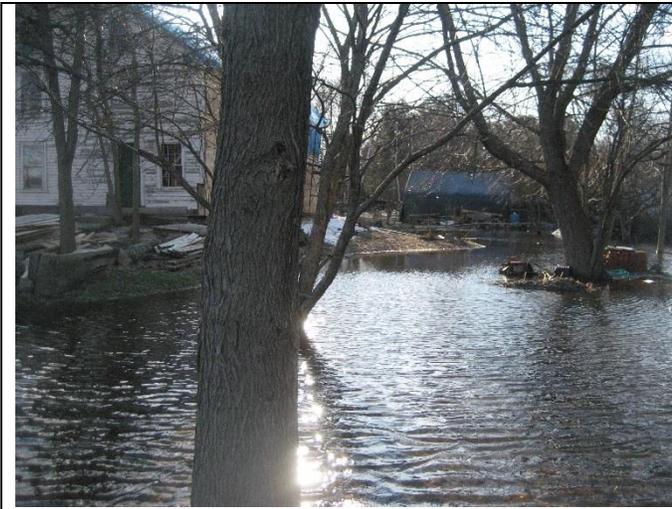
Figure 110 Flood in Rear of House March 2008
