Col. James Barrett Farm

HISTORIC STRUCTURE REPORT

For Save Our Heritage
Concord, Massachusetts

New England Landmarks
Frederic C. Detwiller
Architect & Preservation Planner
302 Central Street
Georgetown, Massachusetts 01833

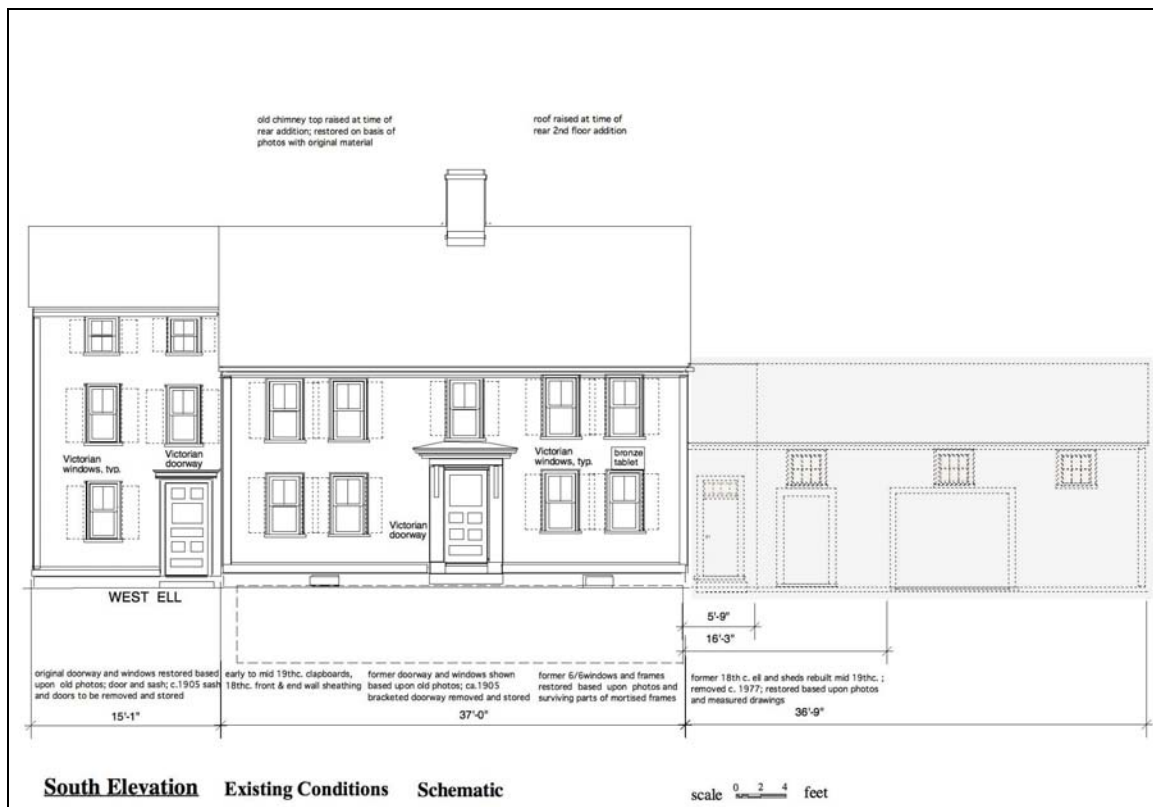
Figure 9 South Elevation – Existing Conditions

The existing house front has retained the form of the early ca. 1705-1768 two-story saltbox with its later 18th century west ell addition. The cut stone underpinning, upper roof and chimney date to the additions by Prescott Barrett ca. 1810. The former East Ell of ca. 1810s to 1860s, shown dotted at the right, is based upon several historic photos taken prior to its demolition, an annotated sketch plan made in 1977, and the fieldstone foundations which remain. Doors, 2-over-2 and 2-over-1 windows date to the turn of the 20th century as do the clapboards, one of which was found on the rear wall with the ca. 1905 stencil of Fraser & Sons, New Brunswick Canada. Former 20th century window blinds seen in old photos are shown dotted. The existing door trim, windows, clapboards and a few framing components of the south wall are seriously deteriorated. Modern asphalt shingles date to within the last ten to twenty years. The bronze wall plaque commemorating Col. Barrett's home and his role in the events of 1775 was installed by the Concord Chapter of the Daughters of the American Revolution in 1961.

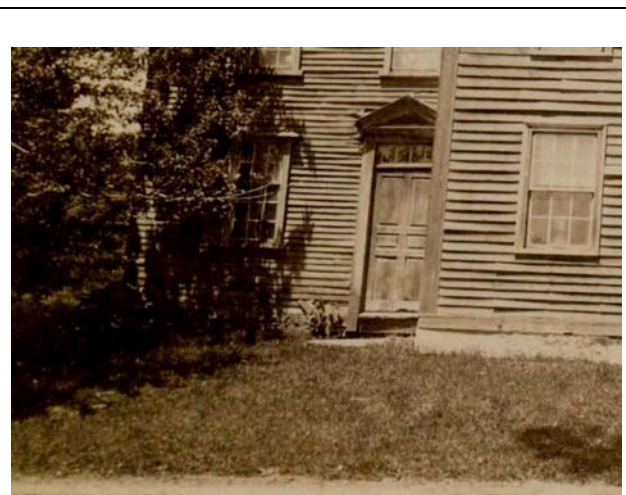
Figure 32 Barrett Ell Entry c. 1880s Detail HNE
Entry had a pediment, four light bulls-eye transom and six-panel door.

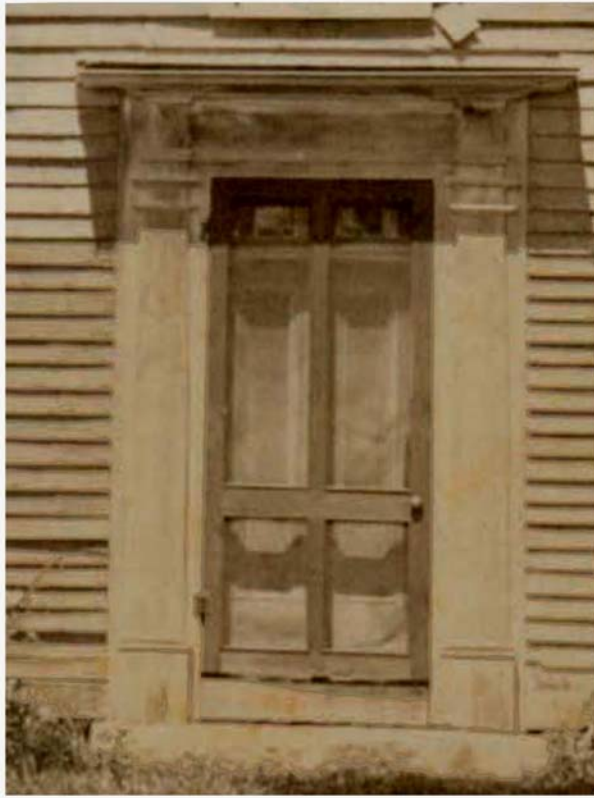
Figure 33 Barrett Main Entry c. 1880s Detail HNE
The front door had pilasters and a five light transom.

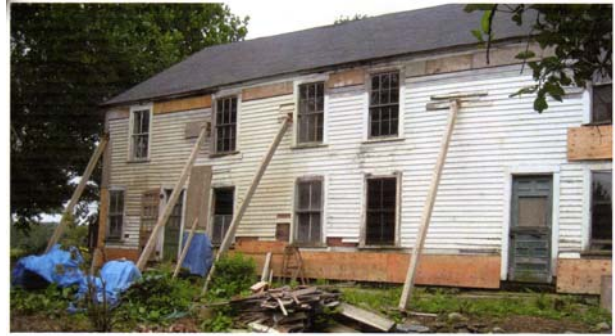
Figure 60 Barrett House NW View with temporary shoring

North (rear) side of Barrett House. Shows wall support structure, coverage of missing sills, and general clearing of landscape.

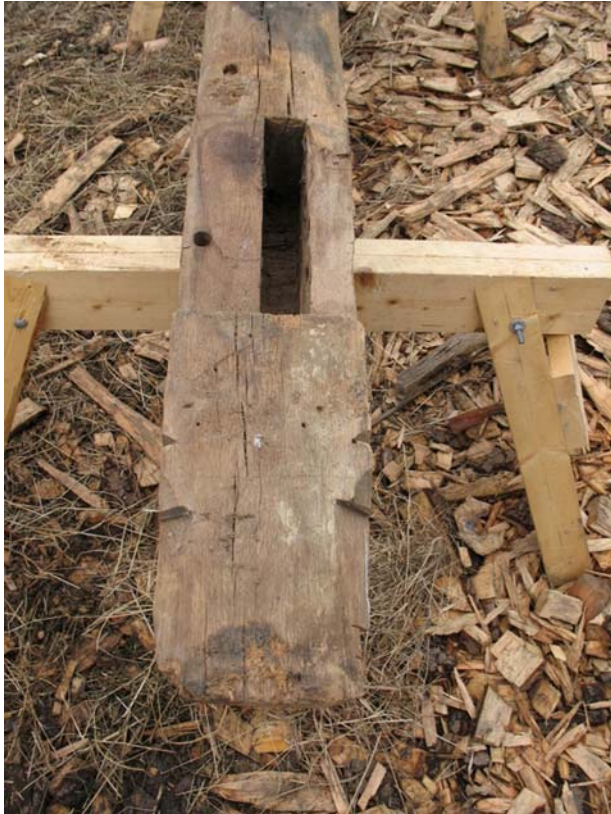
Figure 75 17thc. Re-used Post, Chamfer Detail

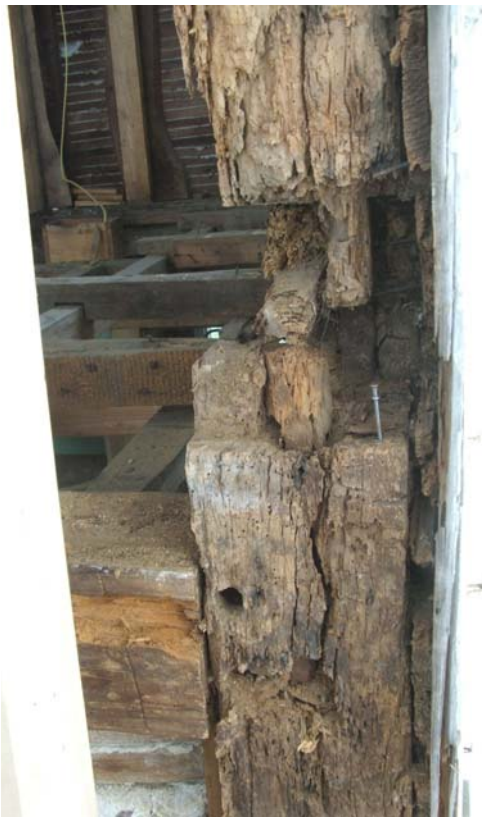
Figure 89 NW Corner Post Deteriorated Joint

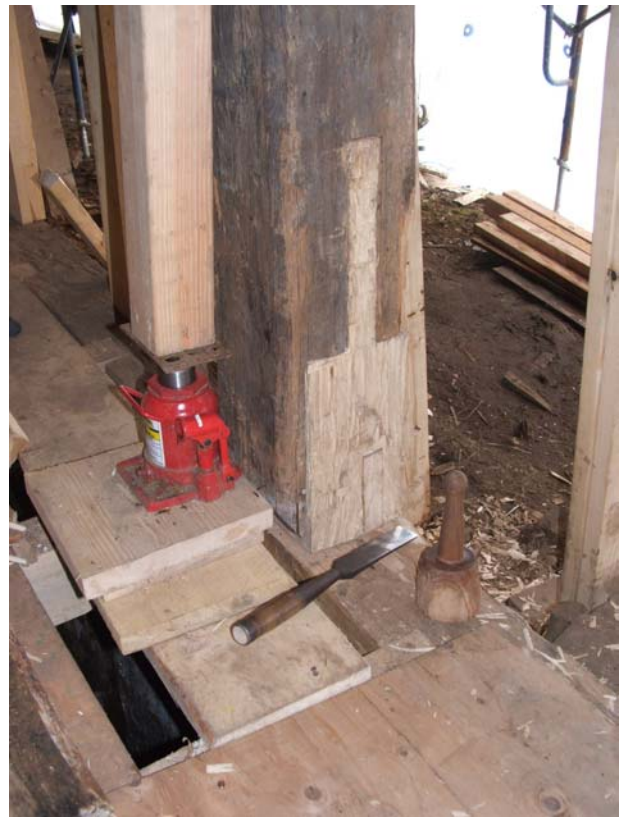
Figure 90 Kitchen Post Base Repair, 2007
