Completion Report

Colonel James Barrett Farm

Period of Restoration - From July 2005 to December 2012

Report Date – November 2016

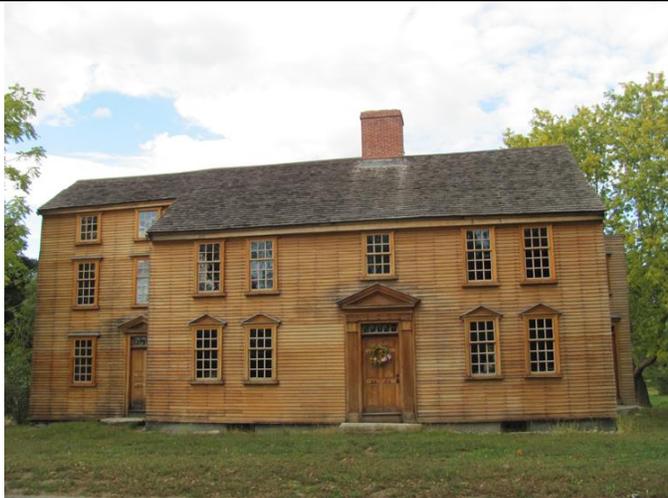
During Restoration

The main house chimney, cracked and reduced in size, was rebuilt to its original size based upon framing evidence. The West Ell stove flue inscribed “built April 1911 was removed as unsafe. The asphalt shingle roof was stripped and rotted sheathing in the process of replacement with white pine 1 in. boards matching the originals. 20th century clapboards were removed and unsound sidewall sheathing and framing replaced where necessary 20th century windows were removed and fragments of molded 18th century plank window frames with shadows of former pediments found.

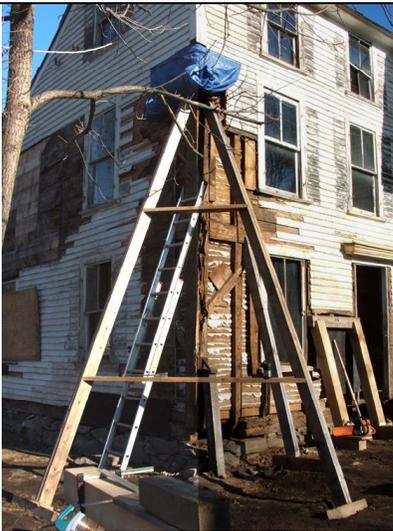
Before Restoration

The exterior had all 20th century doors and windows, clapboards and trim installed ca. 1911. The deteriorated exterior roof sheathing was covered with 20th century asphalt shingles. The house was overgrown with invasives and volunteer sapling trees. The West Ell brick stove chimney, built in 1911, was unstable. All visible exterior finishes had been installed during the 20th century and were considered unsalvageable except for some door, window and trim components saved for future study and/or exhibit. All utility systems had failed or were obsolete and dangerous so temporary electrical and water services were installed to allow work to proceed.

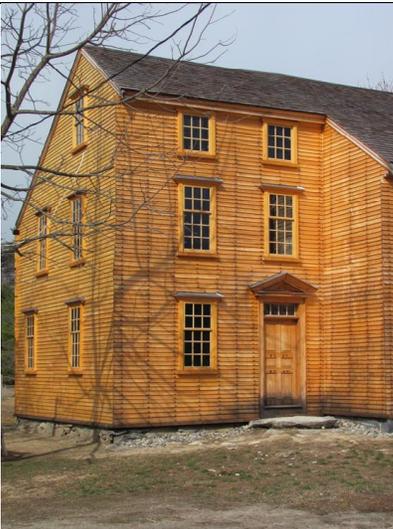
During Restoration

The West Ell northwest and southwest corner post and sills were severely rotted and rebuilt with adjoining braces repaired to its original configuration based upon framing evidence. The west ell stove flue “Built April 1911” was removed as unsafe. The rotted roof and sidewall sheathing boards were repaired with white pine 1 in. boards matching the originals. 20th century clapboards were removed and replaced with authentic skived (end-lapped) heart pine clapboards matching originals. 20th century windows were removed and fragments of plain 18th century plank window frames seen in early photos were found re-used.

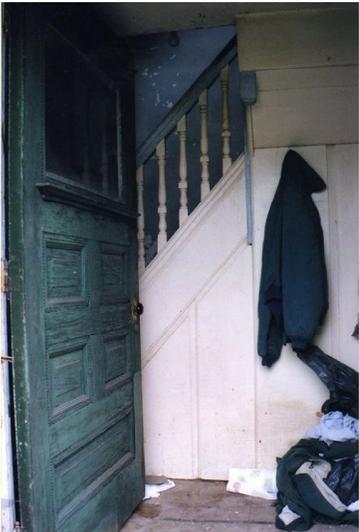
<p>Before Restoration</p> <p>The front entry as found retained all original components: stair, board wall sheathing and plaster. The front door had been replaced in the ca. 1911 exterior renovation. The wide pine finish floor had been replaced with later narrow fir flooring and linoleum floor covering, however the original sub-floor remained. A large accumulation of lead paint had occurred over the years. Early ceiling plaster and chimney wall plaster remained intact. Ceramic wall hanging knobs were visible on the vertical board sheathing at each stair landing. Coat hooks had been applied in the 20th century.</p>

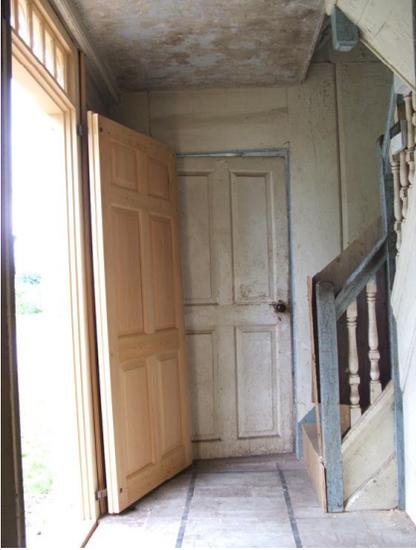
<p>During Restoration</p> <p>The 18th century six-panel front door was restored with a reproduction based upon originals in the house and the West Entry doorway of the Old Manse, built ca. 1770 and matching other woodwork in the parlor, as well as the shadow of the former doorway on the house. The transom with bulls-eye glass was reproduced along with the doorway by the North Bennet Street School. The later paints were peeling, and lead paint needed to be removed for health and safety reasons. The 20th century fir finish floor and overlying linoleum was also removed. All original plaster and early paint remained.</p>

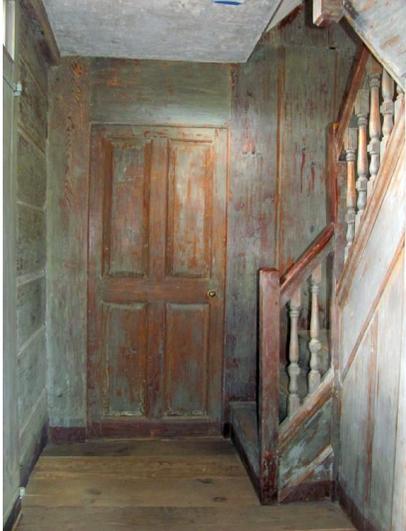
<p>After Restoration</p> <p>The front entry as restored conserves its original color scheme of lead color gray with mahogany color paint on newel posts, hand railings and baseboards. All original woodwork was retained with early paint; conservators needed to do only minor patching and infill of missing paint areas. The finish floor was re-laid with wide pine matching the original. Early ceiling plaster and ceramic wall hanging knobs were retained undisturbed. Traces of a stair runner remaining in underlying paint layers were also preserved, and the mahogany-painted stair stringer retained and conserved. The new front door was painted to match historic color.</p>

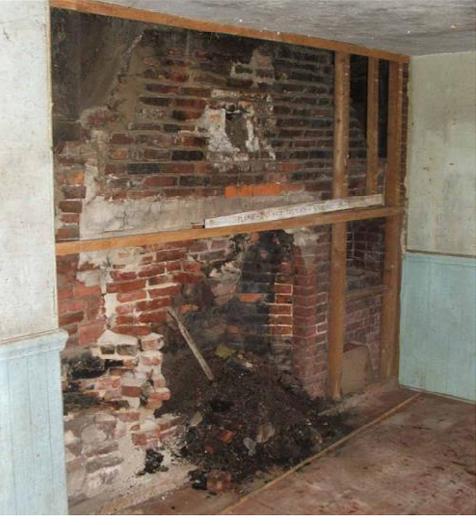
<p>Before Restoration</p> <p>As found, the Kitchen had 20th century plaster on walls and ceilings with bead board dado. The severely rotted floor was covered with 20th century linoleum. The fireplace wall had been hidden behind a large bookcase until its removal revealed the battered cooking fireplace and brick bake oven that had been rebuilt in the early 19th century. Stove flues had been inserted in the brick flue and the remains of a mid-late 19th century boiler were found to the left of the fireplace opening. All visible finishes had been installed during the 20th century, including a kitchen closet in the Southwest corner added by the McGraths.</p>

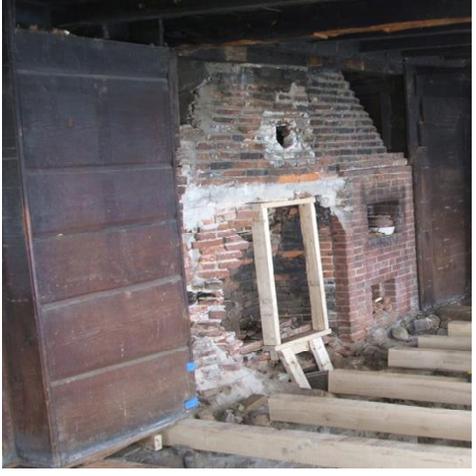
<p>During Restoration</p> <p>The Kitchen after removal of 20th century plaster on walls and ceilings and matched board wood dado revealed 18th century feather-edge board sheathing. The badly rotted floor was re-framed with oak joists similar to originals. The fireplace wall was found to have remnants of the 18th century fireplace jamb. It was decided to retain the evidence of the later fireplace in the hearth, along with the later Barrett period brick oven and ash pit that were in good condition. After structural reinforcement, the original 2nd floor frame and some post and beam casings remained with others reproduced and stained to match. Three batten doors were reproduced: to bedroom, cellar and 2nd floor stair.</p>

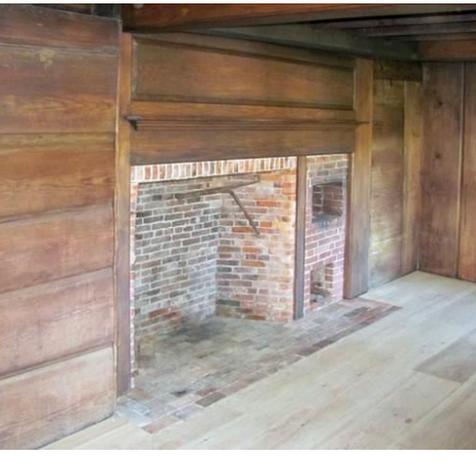
<p>After Restoration</p> <p>The Kitchen after restoration of the fireplace and hearth by masons and woodwork of fireplace surround designed by the historical architect consultant and built by carpenters. Designs were based upon local prototypes of similar period including the Old Manse and the Golden Ball Tavern, as well as evidence at the house. Patched "Dutchmen" and all new wood of white pine were stained by paint conservation specialist to match the original finish. New England white pine post and beam casings and floorboards were installed and stained to match originals after structural repairs to the frame. All visible finishes, after completion of work, reflect the Barrett Period of the 18th and early 19th century.</p>

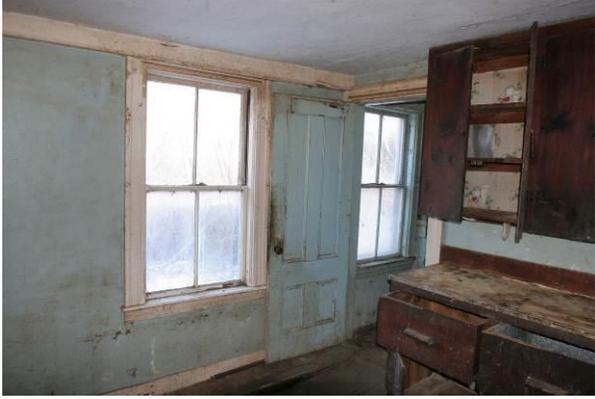
<p>Before Restoration</p> <p>The small north bedroom off the kitchen before restoration still retained its original plaster, door, and trim on the west wall dating to the 18th century. Evidence was found for a former window opening on the west wall under the West Ell stairs adjacent. The plaster covering the former west window of the main house, and the west door to the Ell stair were added in the 18th century. This was most likely done during Col. Barrett's renovation of the house ca. 1768, as the roof framing of the main house and West Ell appears to be continuous. The accumulation of lead paint made it necessary to remove most of the overlying peeling paint layers along with 20th century linoleum and a 20th c. electric light fixture added by McGraths.</p>

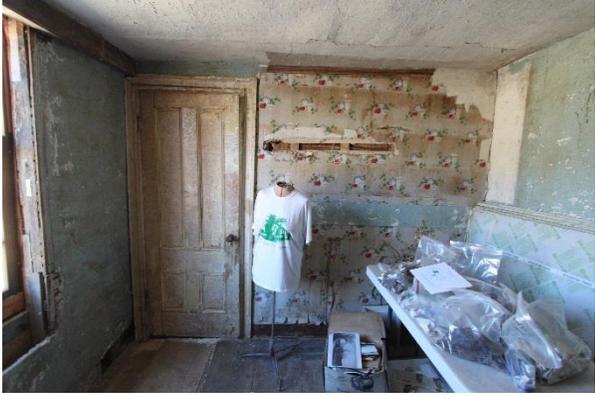
<p>During Restoration</p> <p>The bedroom interior, as found, had been made into a pantry/kitchenette by the McGraths. The east wall had mid-20th century cabinets and wallpaper removed revealing the 20th c. plaster layer added over former 18th c. plaster evidence. The kitchen door to the left had been replaced in the early 20th century by a 4-panel door with a towel roller. The earlier window had been replaced in the 20th century, but the exterior wall, west and south interior walls and ceiling plaster was original. An early wrought iron hook or eye in the ceiling for hanging bed curtains or a lantern remained. All were temporarily supported with shoring during structural work for later conservation along with the original wide pine floor and painted boarder.</p>

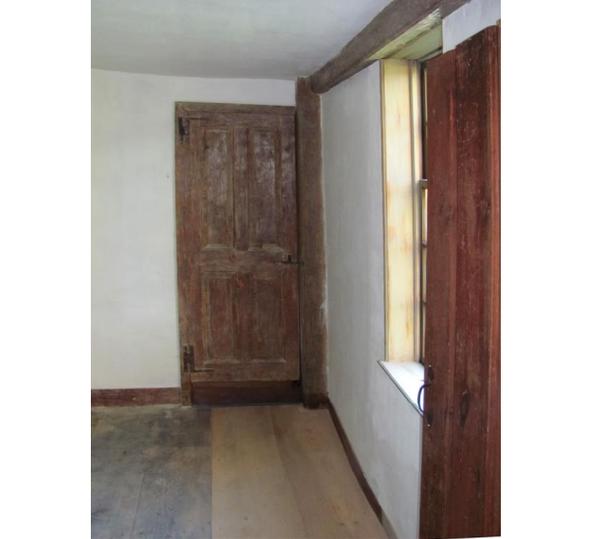
<p>After Restoration</p> <p>The original 4-panel door, hardware and trim were preserved. The early paint color of the room, a blue-gray, was preserved and conservators in-painted the areas that had been damaged to match the original. Baseboards were also retained with the original mahogany color extending across the bottoms of the doors and corner posts. The reproduction batten door to the kitchen was stained to reflect its early appearance. The two northernmost floorboards were worn too thin to be re-used but were salvaged and stored for study and exhibit. The early black painted border remains showing the shadow of a former floor cloth. Wall and ceiling plaster was painted with simulated whitewash to reflect the Barrett Period.</p>

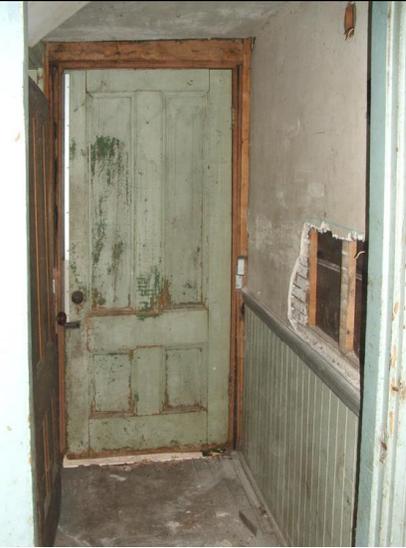
<p>Before Restoration</p> <p>The East Entry as found had been rebuilt in the mid-19th century and demolished after the collapse of the East Ell in 1977. The foundation, large granite doorstep and cobble paving date from the 18th century. The East Ell entry, based upon the comparable example at James Barrett Jr. house at 612 Barrett's Mill Road, probably had an entry separated by a partition that would have dated to Col. Barrett's rebuilding of ca. 1768. Plans were made to remove the 20th century infill wall with its McGrath Era door and window and reconstruct the East Entry. Plaster and a narrow bead-board wainscot covered the south wall of horizontal board sheathing in the remaining part of the entry and a later 4-panel door led to the cellar.</p>

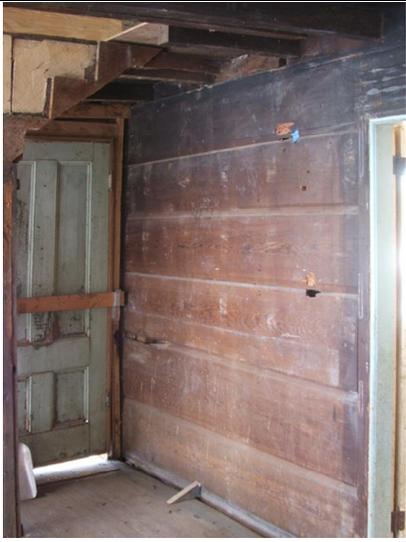
<p>During Restoration</p> <p>The East Entry interior had 20th century plaster and narrow board dado sheathing removed revealing the original unpainted pine feather-edge sheathing of the room with remnants of former coat hooks. The four-panel exterior door and east wall had been added after the shed and old east entry fell down in 1977. The ceiling had traces of early plaster lath fastened with wrought nails suggesting it had been finished about the time Col. Barrett rebuilt the house ca. 1768. The entry also retained evidence of the partition and over-door of the doorway into the cheese room or dairy that was also once plastered on the ceiling, but had original board sheathing remaining at the stair partition on the west. The stair partition facing the kitchen had been briefly removed for framing repairs.</p>

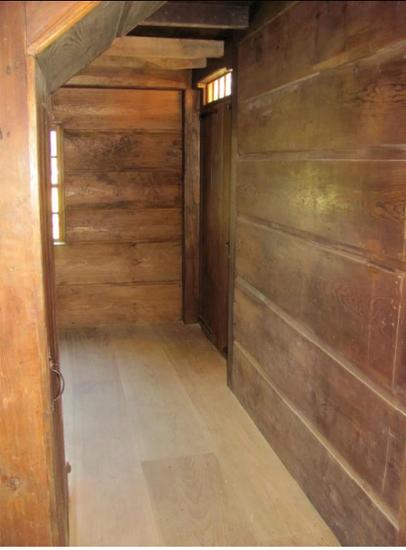
<p>After Restoration</p> <p>The East Entry was rebuilt based upon fragments, 1977 photos of the collapsed east ell and sheds, as well as the similar framing and sheathing of the James Barrett Jr. east entry. Original 18th century pine sheathing of the room was preserved. Carpenters reproduced missing sheathing, conservators stained patched areas to match original. The missing finish floor was reproduced to match existing Barrett-era floors. The severely decayed batten door to the cellar (kept for exhibit) was reproduced and installed below the kitchen stair on original pintles. The entrance door was reproduced from the original at the Concord Museum. The former vertical board partition separating the entry from the dairy-cheese room remains to be restored.</p>

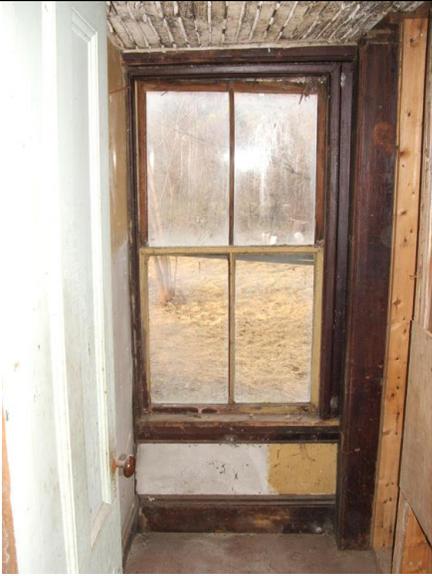
<p>Before Restoration</p> <p>The Cheese Room or Dairy as found had been rebuilt in the mid-19th century and demolished after the collapse of the East Ell in 1977. A three-foot section of the dairy remained and plans were made to remove the 20th century infill wall with ca. 1910s doors and windows and reconstruct the East Entry. Archaeologists performed a study that found the foundation, cobble paving and associated artifacts dating from the 18th to the mid-19th century. Photographic and physical evidence was found for a former jut-by with shed roof similar to one from the Thomas Barrett House at Barrett’s Mill. The East Ell entry, based upon the comparable example at James Barrett Jr. house at 612 Barrett’s Mill Road, likely had a dairy or cheese room that would have dated to Col. Barrett’s rebuilding of ca. 1768.</p>

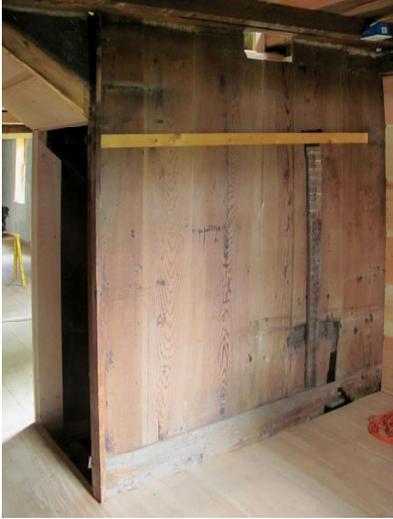
<p>During Restoration</p> <p>The Cheese Room or Dairy interior had later 20th century plaster removed revealing the original framing of the ceiling and wrought nails of a former 18th c. plaster ceiling. The original 18th century vertical board sheathing of the stair partition had plaster added later in the 19th or early 20th century. The board partition showed the remnants of the partition between the entry and the dairy, with shadows of H hinges and a piece of the over door board remained giving the 27-inch width of the door. The shadows of shelf cleats remained over the door and near the exterior wall. A rotted hole and shadow of a cleat bore witness to the previous existence of a wooden dry sink, a common feature of a dairy room.</p>

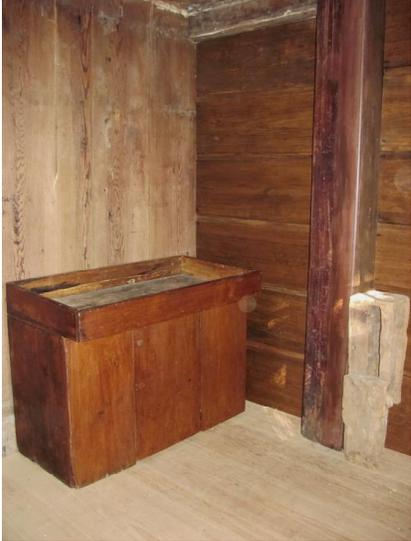
<p>After Restoration</p> <p>The early vertical board stair partition was preserved and carpenters re-installed pine horizontal sheathing matching the entry wall and Dairy room of the James Barrett Jr. House at 612 Barrett’s Mill Road. Conservators stained the new wood and areas that had been damaged to match the original. The re-used base of the original NE corner post of the saltbox house had chamfers and stops that date it to the First Period. The post base, too weak to be re-installed, has been preserved for exhibit. The original post casing was repaired with missing beam casing elsewhere made to match the original. An authentic early dairy dry sink was found in Rowley, MA. The partition and shelving remain to be restored to reflect the 18th c. Barrett period appearance of the Cheese Room-Dairy.</p>

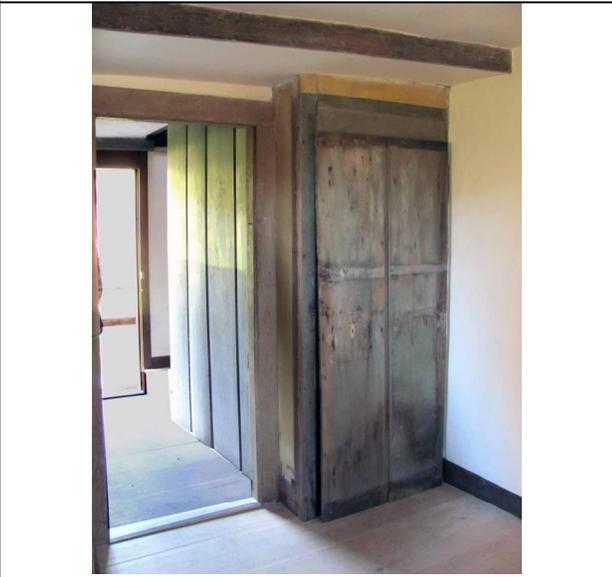
<p>After Restoration</p> <p>Evidence was found for the original partition location and the position of the original cellar stair batten door, rebuilt with fragments of the original door found re-used as sub-floor in the back room. The early gray paint color of the room was preserved; conservators in-painted the new and repaired areas to match the original. Baseboards retain the original and restored mahogany color extending across the base of the doors and corner posts. New or patched woodwork was painted and plaster walls whitewashed to reflect as far as possible the appearance of the West Ell Front Room in the time of Col. Barrett. The large chimney, cooking fireplace and paneled chimney wall, similar to that in the West Ell of the James Barrett Jr. House at 612 Barrett's Mill Road, remains to be restored.</p>

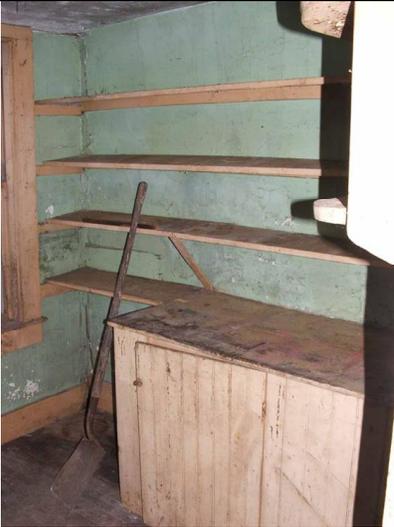
<p>Before Restoration</p> <p>The West Ell Back Store Room as found had lost all but the corner post casing from the 18th century. It did retain pantry shelves, counter top and flour cupboard dating to the ca. 1911 renovation by McGraths, but recalling its probable Barrett-era use as a pantry. The partition to which the shelves were attached was rebuilt in the ca. 1911 renovation in the same location as the vertical board partition of the Barrett Period. Ceiling and floor framing retained clear evidence of the original West Ell front room kitchen fireplace chimney location, with one joist chamfered to allow passage of the brick oven flue, probably built during the Colonel's lifetime.</p>

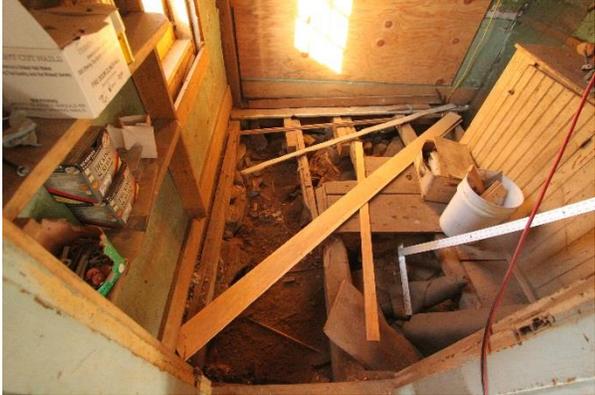
<p>During Restoration</p> <p>The West Ell Back Store Room interior retained original framing of the 18th century one-story saltbox. Although deteriorated and replaced, the NW corner post and its casing were salvaged for re-use, study and/or exhibit. Evidence was found for a former board wainscot to window sill height on the west wall only. The original plaster remained on the north wall, despite the insertion of a large window there in the 20th century renovation. Framing and nailing evidence showed the ceiling had been originally plastered. Overlying lead paints were removed revealing the original paint colors on various components of the room. Woodwork was mostly unpainted until later in the McGrath renovation of 1911.</p>

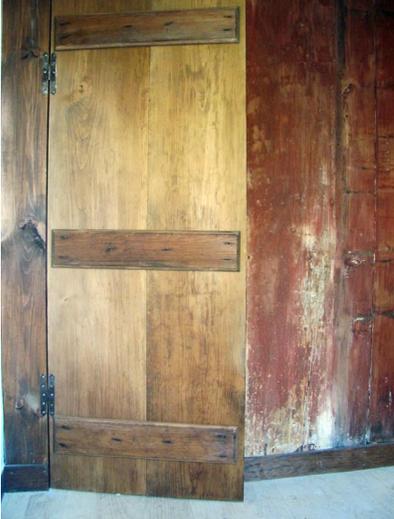
<p>After Restoration</p> <p>The board partition between the NW Store Room and the entry was rebuilt in its original location using salvaged sheathing boards from an 18th century house of comparable date and style. Later layers of paint and wallpaper on these boards were removed on the Store Room side. However, early red-brown paint or stain and grain painted finish on the entry side were retained as they nearly matched the early Barrett finish. A new batten door was constructed based upon other Barrett batten doors and stained by paint conservators to match the historic finish on boards remaining from the time of Col. Barrett. A new wide pine wood floor matching the others in the house was installed over reinforced original floor joists around the old chimney opening.</p>

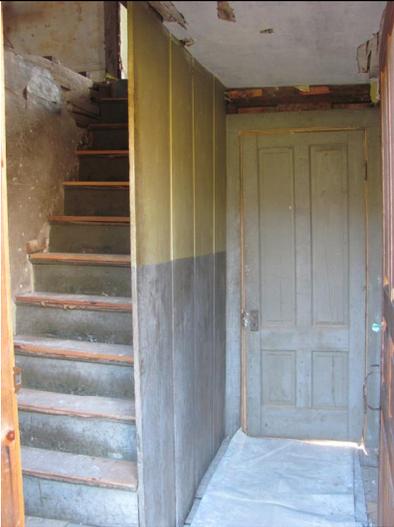
<p>Before Restoration</p> <p>The West Ell Entry/Stair Hall as found retained most original woodwork dating to the 18th century. The stair to the left was added over the earlier west window of the main house likely during Col. Barrett’s rebuilding of ca. 1768. The stair and vertical board partition adjacent, as well as the ceiling and wall plaster all probably date to the Colonel’s lifetime. Evidence was found for a former vertical board partition to the right, likely removed during the ca. 1911 McGrath remodeling when the four panel door to the front room was also installed. The late Barrett or early McGrath Period paint on the stair partition remained along with some “turkey carpet” floor cloth fragments re-used on the stair, probably salvaged from a front room.</p>

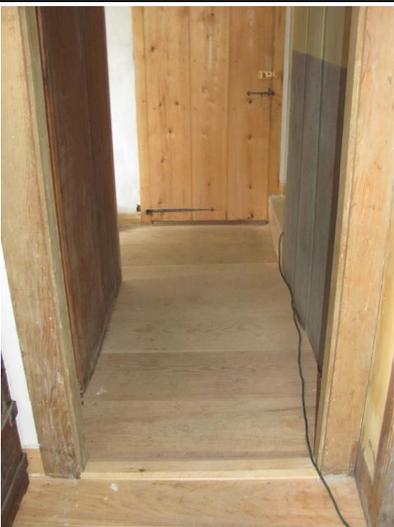
<p>During Restoration</p> <p>The West Ell Entry/Stair Hall interior had a couple of layers of early 20th century composition floor coverings in checkerboard patterns, probably similar to earlier floor cloths, typical of the late 18th and early 19th centuries. The badly rotted, ca.1911 floor had to be rebuilt with original joists below sistered and a new wide pine sub-floor and finish floor to match original. The partition to the left had been rebuilt by McGraths from old floorboards. Other re-used fragments, including part of the batten door to the cellar, were found in the sub-floor. The exterior door was reproduced based upon the original in the Concord Museum, with one pintle of the original door, apparently replaced ca. 1911, preserved in place.</p>

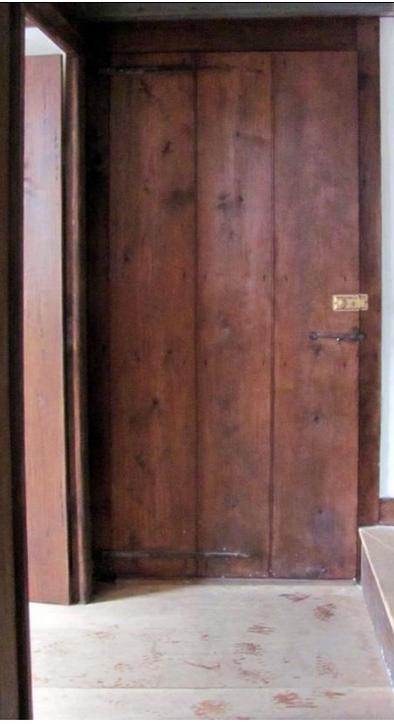
<p>After Restoration</p> <p>The original plaster ceiling and east stair wall were conserved, repaired and whitewashed to match the original. Woodwork, originally mostly unpainted, at first had only mahogany color baseboards, with the gray and buff colors added to the stair partition in the late Barrett Period. These old paint colors of the partition were preserved and conservators in-painted or stained the areas that had been repaired or replaced to match the original wood color tying the room together. The vertical board partition was restored using salvaged 18th c. boards already grain painted with a wood finish very similar to the original. The exterior and interior reproduction doors were stained, and mounted on wrought iron hardware to reflect the appearance of the entry in the time of Col. Barrett.</p>

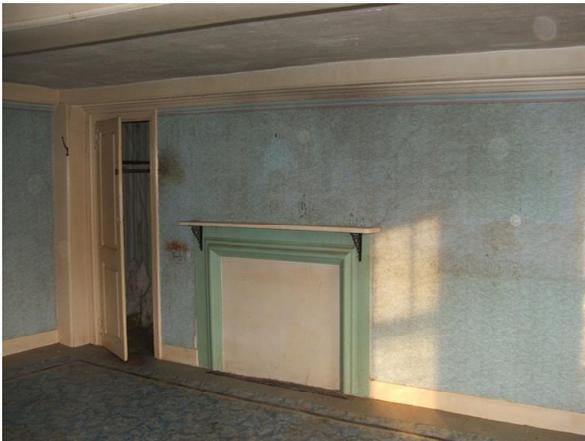
<p>Before Restoration</p> <p>The West Chamber as found retained all its original woodwork dating to the 18th century. The pilaster, doors, fireplace bolection and trim all probably date to Col. Barrett’s rebuilding of ca. 1768. The fireplace bolection molding and two and four-panel doors with Queen Ann finial H hinges all date to the 18th century during the Colonel’s lifetime. The fireplace had been bricked up as early as the 1860s when front rooms were heated by stoves, according to Barrett inventories. The accumulation of lead paint made it necessary to remove most of the overlying layers to meet safety and health codes.</p>

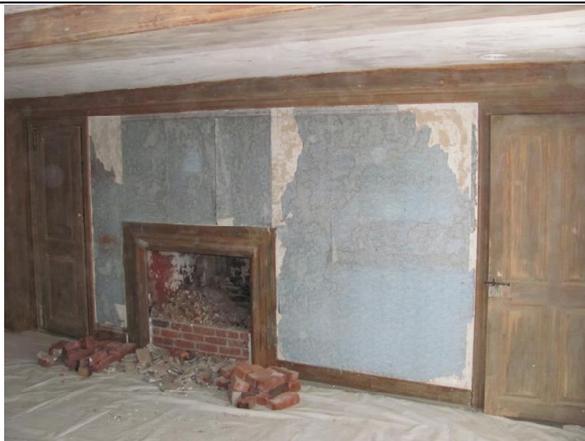
<p>During Restoration</p> <p>The West Chamber interior had overlying lead paints removed revealing the original paint colors on various components of the room. The painted border around the floor surrounded the 20th c. floor covering, beneath which was evidence of earlier smaller floor cloths. Evidence was found for original plaster parging in the deep firebox all probably predating the Revolution. The paint evidence showed that the fireplace surround and were marbled in the 18th century. The walls had traces of wallpaper dating as far back as the 1810s and these, along with others from the four front rooms are stored in files for future reference.</p>

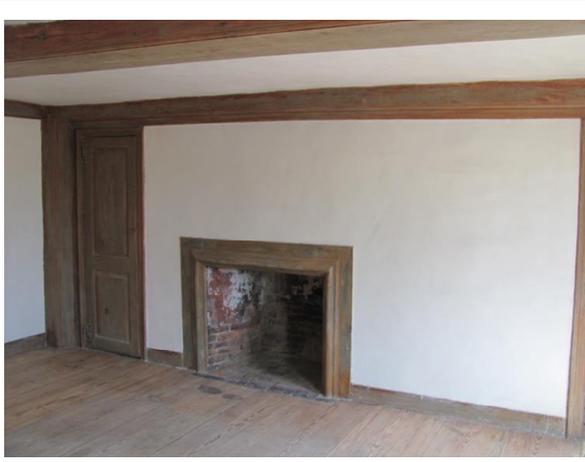
<p>After Restoration</p> <p>The early paint color of the West Chamber room, a gray-green, was preserved and conservators in-painted the areas that had been damaged to match the original. Cleaning of the paint from the floor, a gray border around a smaller, earlier former floor cloth, revealed old burn marks beneath in front of the fireplace. Baseboards, unlike the other principal rooms, did not have the mahogany color painted baseboards extending across the bottoms of the doors and corner posts. The marbleizing of the fireplace bolection molding and parging in the firebox has been carefully preserved as an important and rare survival of 18th century decoration to reflect the ca.1775 appearance of the room at the time of Col. Barrett.</p>

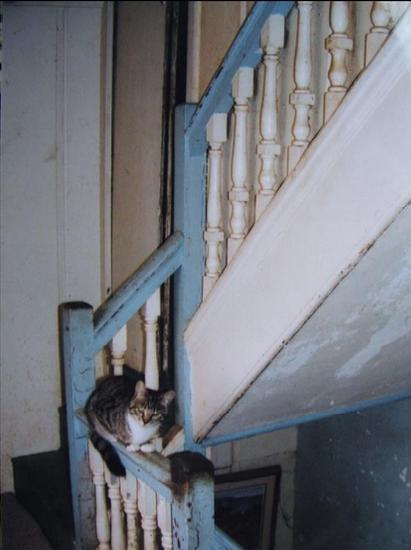
<p>Before Restoration</p> <p>The Upper Entry as found retained all its original woodwork, stairs and railing dating to the 18th century. The horizontal board sheathing on the exterior wall and vertical board sheathing on the interior partitions all probably date to Col. Barrett’s rebuilding of ca. 1768 if not before. The closed string stairway with its turned balusters and heavy molded handrail mortised into the square newel posts are all typical of the early to mid-18th century. The accumulation of lead paint on all woodwork including the board sheathing, stairway railing, risers, treads and wide pine floors, made it necessary to remove most of the overlying layers to meet safety and health codes.</p>

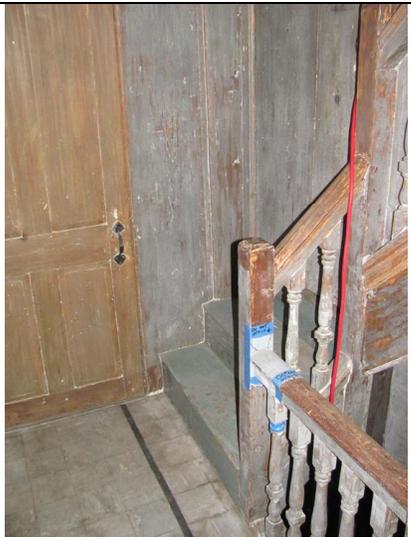
<p>During Restoration</p> <p>The Upper Entry interior had overlying lead paints removed revealing the original paint colors on various components of the room. The paint evidence showed that the lead-color gray woodwork had mahogany color baseboards that extended over the bases of doors and around corner posts. The stair railing had the hand rail and tops of the posts painted a mahogany color as well. Areas of original paint strata were left intact for later study. The 20th century composition floor covering remained in place over the original wide pine floor in order to protect it until paint conservation treatment was completed.</p>

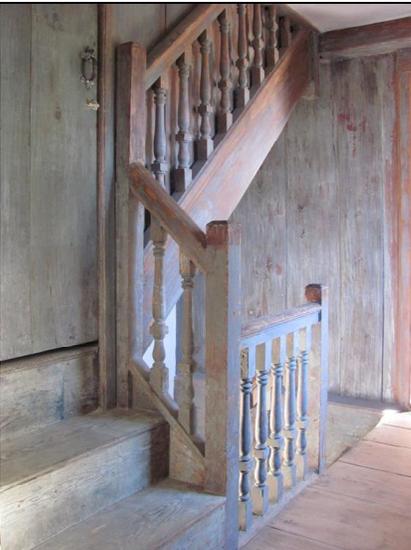
<p>After Restoration</p> <p>The early paint color of the Upper Entry, a lead color gray, was preserved and conservators in-painted the areas that had been damaged to match the original. Baseboards were also conserved and retain the original mahogany color extending along the stair stringers and chimney wall, and around landings, as well as across the bottoms of the doors and corner posts. The original hardware remained on the very early 18th century bi-fold door to the attic. Stair risers and treads preserve traces of a former narrow runner. The front wall was patched around the six-over-six window above the front doorway pediment, restored to reflect to the period of Col. Barrett ca.1775.</p>

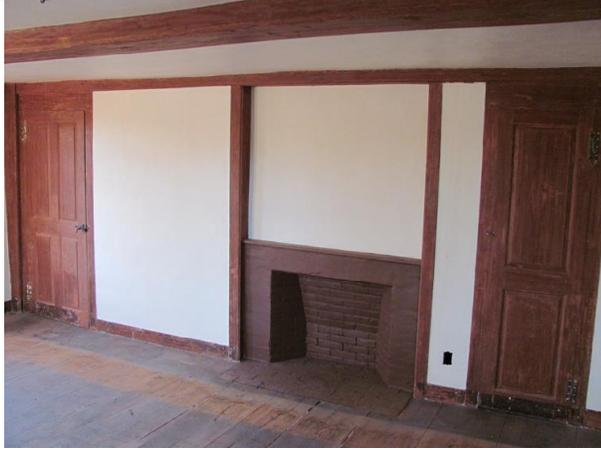
<p>After Restoration</p> <p>The early cedar-grained paint decoration of the East Chamber was preserved and conservators in-painted the damaged areas to match the original. Baseboards were also in-painted but retain most of the original mahogany color extending across the bottoms of the doors and corner posts. The walls were painted with simulated whitewash, presumed to be the earliest finish according to paint study analysis. The paint on the fireplace surround is restored to match the hearth dating to after the time of Col. Barrett when it had the vertical board sheathing exposed. Now the room reflects its appearance as of the time of his grandson Prescott's occupancy ca. 1808 to 1862.</p>

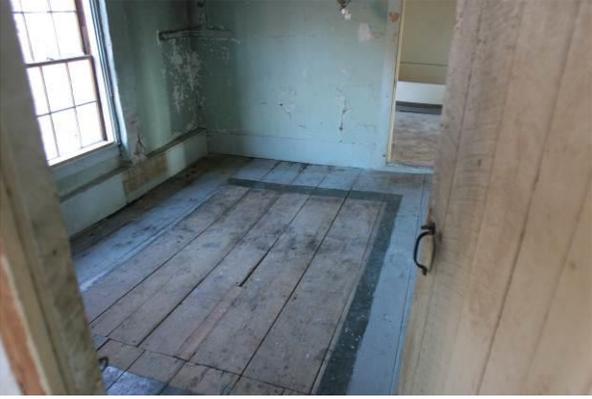
<p>Before Restoration</p> <p>The Kitchen Chamber (over the kitchen) as found had a ca. 1810s addition of the second floor rear in an area that had originally been a low lean-to room of the former salt-box. However, it retained some of its woodwork, floor and finishes at the chimney wall dating to 18th century. The plaster, closet door and trim on the south wall all likely date to Col. Barrett’s rebuilding of ca. 1768. The location of the closet over the kitchen fireplace, along with its wrought iron H hinges and hasp for a padlock, suggest its possible use as a gun closet. A seam in the plaster above the door shows where the ceiling was raised when the second floor rear was added. Evidence was found for former partition locations under later floor cloths.</p>

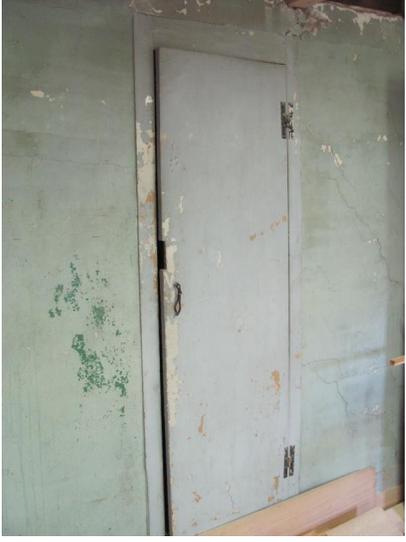
<p>After Restoration</p> <p>The early paint and plaster finishes, door and trim woodwork were preserved unchanged as they evolved over the years on the original surfaces. Baseboards also retain the early as well as later paint. Floors retain the later painted borders around former floor cloth locations reflecting the later partition layout. The original floorboards retain mortises for the studs of the initial board partitions and original door jambs remain adjacent to the chimney wall dating to the time of Col. Barrett. The only remaining feature to be restored on the chimney wall is the keeper and a padlock for the closet that probably held the muskets mentioned in the ca. 1808 inventory of Peter Barrett. Board partitions remain to be restored.</p>

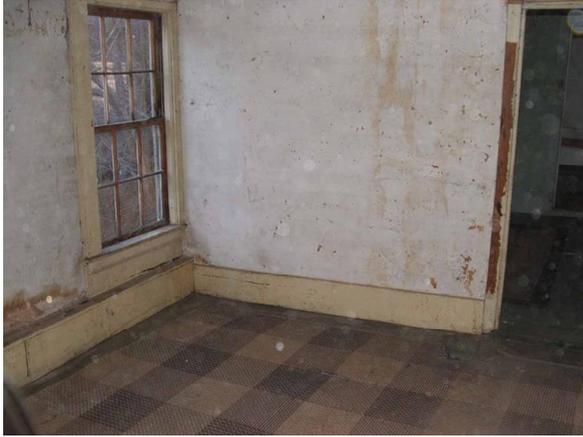
<p>Before Restoration</p> <p>The North Chamber as found retained some original woodwork dating to the 18th century despite the removal of the saltbox roof and the ca.1810s addition raising of the second floor ceiling and roof. Although later 20th century plaster existed on the rebuilt north wall and partitions, original plaster remained on the south wall, along with an original 18th century door to the West Ell stair. The original 18th century door jamb remained attached to the south wall although the partition had been relocated. The 19th century plaster partitions, windows, and trim covering the 18th c. roof plate (below window sill level) remained, along with a straw carpet of probable 20th century original, although the 1862 Prescott Barrett Inventory listed one in the East Chamber.</p>

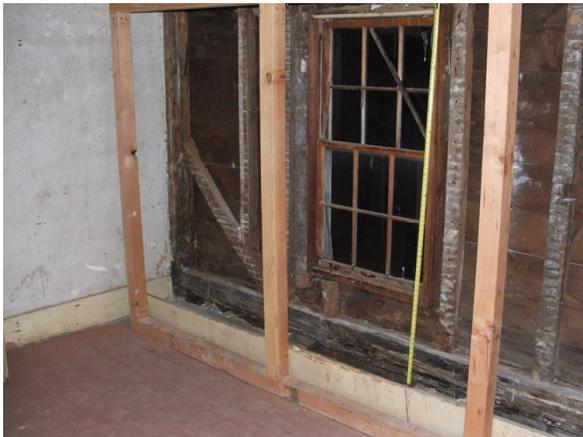
<p>During Restoration</p> <p>The North Chamber interior had overlying 20th century plaster removed for structural repairs revealing re-used 18th century framing in the rebuilt exterior wall. Wall framing included a stud made from the rail of a rope bed dating to the 18th century. Ceiling (attic floor) framing and wall plates of the old saltbox (below the window sill) and the later 19th century roof plate above were rotted beyond repair. However, original floorboards, re-used early 18th century posts, beams, and studs were preserved and restored to their former locations. The 20th century partitions needed removal to repair framing. The 18th and 19th century components were preserved.</p>

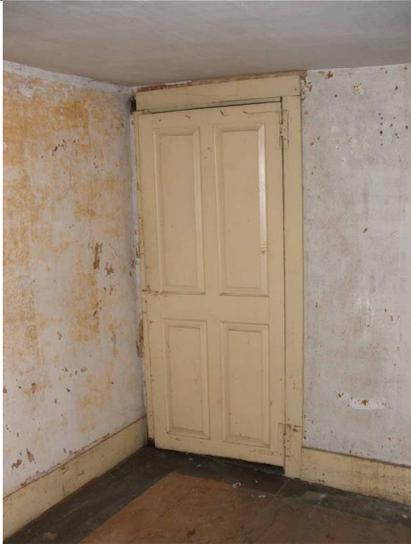
<p>After Restoration</p> <p>Early yellow ochre paint color on the 18th century plaster of the south wall was preserved untouched. Baseboards retain the early as well as later paint. Floors retain the later painted borders around former floor cloth locations reflecting the later partition layout when the North Chamber was enlarged in the 19th or early 20th century. The original floorboards retain mortises for the studs of the initial board partitions. Original door jambs remain adjacent to the chimney wall dating to the time of Col. Barrett. Remaining to be restored are board partitions of the ca.1810s addition. One re-used partition board preserved was stenciled with "P. Barrett Concord," probably Prescott.</p>

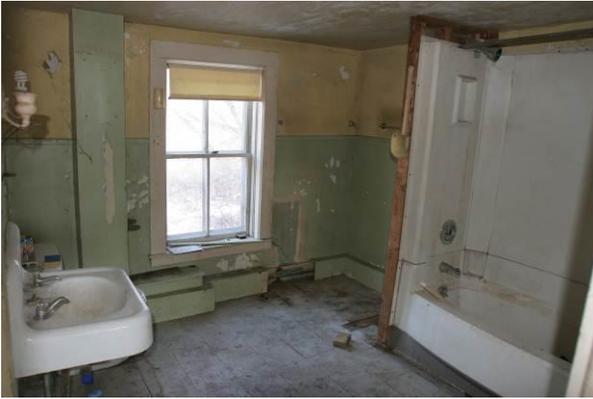
<p>Before Restoration</p> <p>The East stair area as found retained little of its original woodwork dating to the 18th century. The sub-floor and framing in part dates to Col. Barrett’s rebuilding of ca. 1768. The floor at the East Chamber doorway retained a mortise for a door jamb from the former 18th century board partition in the same location as the later 20th century rebuilt partition. The door jamb still attached to the south wall has the shadows of former H hinges dating to the Colonel’s lifetime. The existing 20th century bathroom’s west partition with its two-panel door, plaster and paint, showed the shadows of the former sink added over the closed kitchen stair.</p>

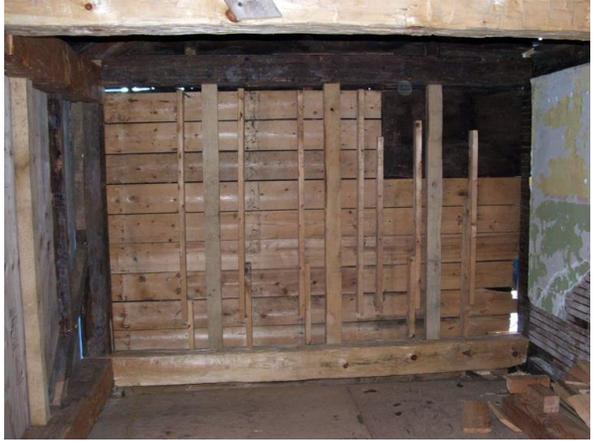
<p>During Restoration</p> <p>The East stair area’s interior had 20th century plaster at the location of the former bathroom tub removed to reveal the ca. 1970s sheathing and 2-by-4 studs added when the East Ell was removed ca. 1977. The original end lower girt was reproduced in its former location, along with the ca. 1810s studs for which mortises remained in the added upper girt. Wide board sheathing at the upper right would have been added when the old saltbox was raised to a full two stories ca. 1810, or possibly re-used later in 1977. The old plaster on the south wall, dating from the 18th to 20th centuries, was retained. Areas of sub-floor and finish floor were patched to match original.</p>

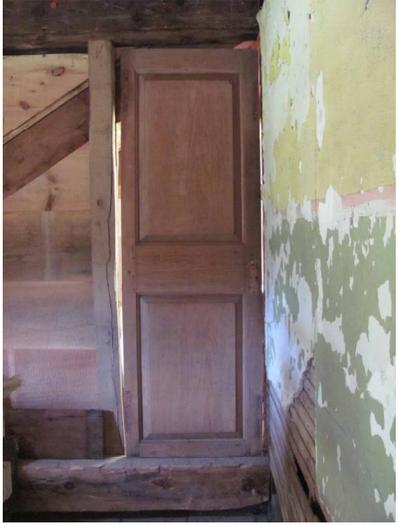
<p>After Restoration</p> <p>The East Ell was rebuilt and the 20th century sheathing and studs removed to allow installation of the door to the East Ell Chamber as it would have appeared in the time of Col. Barrett. A salvaged two-panel door matches other 18th century doors in the house. The East Chamber restoration was important as it was probably the door to Philip’s Room. Philip was Col. Barrett’s servant until the Colonel’s death in 1779. The stair to the kitchen was re-opened, and was temporarily railed with a board railing pending further evaluation of sketchy evidence for its original and ca. 1810s treatment at this level. The area has been left unfinished as a study space.</p>

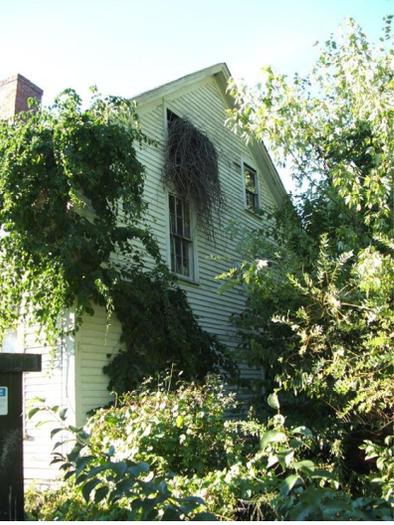
<p>Before Restoration</p> <p>The East Entry Ell had been altered in the mid-19th century and removed in 1977. The side of the house had been rebuilt with new clapboards applied where the East Entry Ell had been. Invasives such as bittersweet had grown into the windows of the house. A bathroom had been installed against the exterior wall where the ell had formerly been. Fortunately, in 1977 photos had been taken (illustrated elsewhere) by the National Park Service's Orville Carroll and others that showed the remnants of the original East Entry Ell framing. These and comparative evidence at the James Barrett Jr. House at 612 Barrett's Mill Road, with the footprint of the ell here, provided the information needed to reconstruct the East Entry Ell.</p>

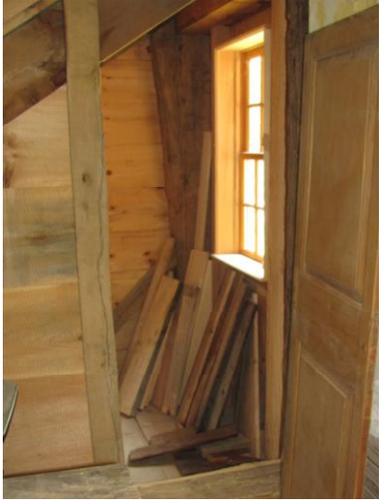
<p>During Restoration</p> <p>The East Entry Ell frame was reconstructed by timber framers on the old foundation that had been rebuilt, with framing reproducing that still remaining at the James Barrett Jr. House at 612 Barrett's Mill Road. The shed-roofed ell was based also on the Thomas Barrett House, of which an 1862 watercolor showed a door at the second floor level leading into the former ell. The East Ell chamber, Room 207, was probably Philip (Col. Barrett's Servant)'s room and was near the top of the kitchen stair, as found in a 1770s slave's room still extant at the Judge Holten House in Danvers MA. The framing was then clad in wide pine sheathing and skived clapboards similar to those on the rest of the house.</p>

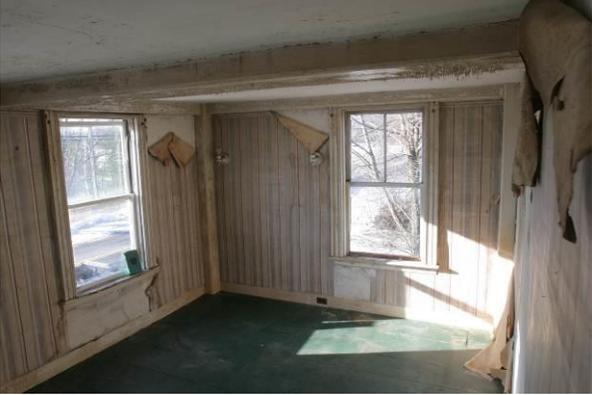
<p>Before Restoration</p> <p>The SW Ell Chamber as found retained all its original plaster and woodwork dating to the 18th century except the windows and chimney wall (installed ca. 1911) that replaced the early fireplace and chimney partition of wood. The plaster and woodwork that remain on the other three walls all probably date to Col. Barrett’s rebuilding of ca. 1768. Evidence was found in the original wide pine floor behind the chimney partition for a former fireplace hearth from the 18th century, dating to the Colonel’s lifetime. The accumulation of lead paint made it necessary to remove most of the overlying layers to meet safety and health codes.</p>

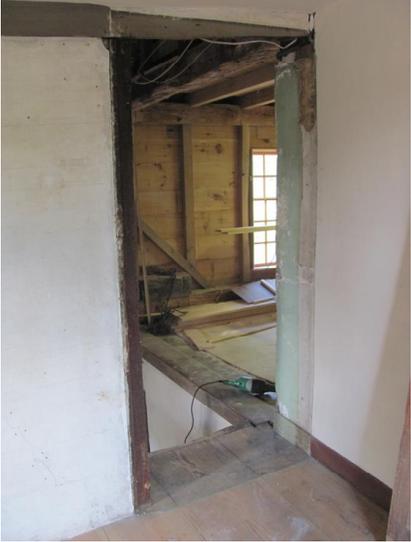
<p>During Restoration</p> <p>The SW Ell Chamber interior woodwork had peeling upper lead paints removed. Removal of ca. 1911 door jamb at the north chimney partition revealed ca. 1810s yellow ochre and blue floral stripe wallpaper and mortises in the floor indicating the original chimney partition was about one foot north of the ca. 1911 one. The paper was likely installed ca.1815. Some original paint remained exposed on window heads beneath the 1911 window trim as well. The woodwork had a blue-gray-green as its first coat of paint. The early paint color has been matched on the other components of the room. Woodwork had mahogany color baseboards, at first extended across doors, but not in the later Federal Period.</p>

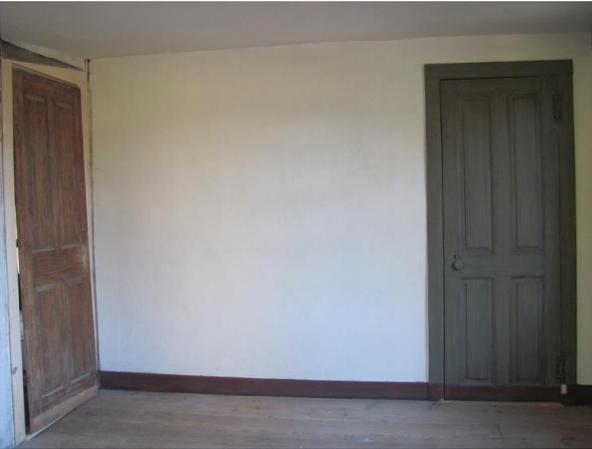
<p>After Restoration</p> <p>The early paint color of the SW Ell Chamber, a blue-gray-green, was preserved and conservators in-painted the areas that retained some later coats of paint to match the original. Baseboards were also repainted to match the original mahogany color extending across the bottoms of the doors and corner posts. The later green floor paint was removed to reflect the ca.1775 appearance of the chamber. The north partition door was replaced with reproduction trim and a salvaged 18th century door to reflect the period of occupancy by the Barrett family. The West end of the house served as the widow’s dower third of the property in the settlement of the estates of both Col. Barrett in 1779 and son James Jr.’s home nearby in 1799.</p>

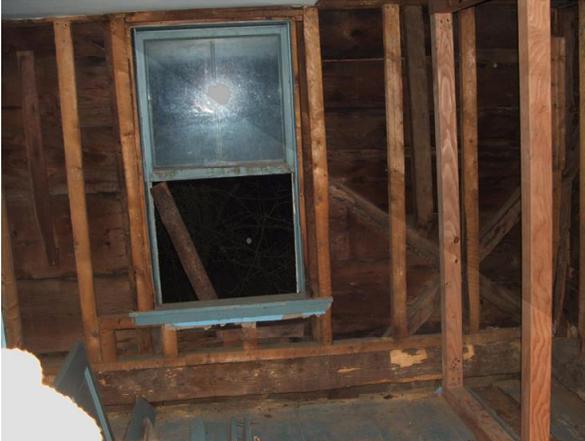
<p>Before Restoration</p> <p>The NW Ell Chamber as found retained its floor and framing dating to the 18th century. The end wall after removal of 20th c. plaster revealed in the sheathing and framing the line of the former saltbox dating from ca. 1768. The floor retained the opening cut out for the original second floor chimney with its hearth and mortises in the floor for a door at each end of the former board south partition. The chimney with its fireplace opening into the front room would have resembled that still extant at the James Barrett Jr. House at 612 Barrett's Mill Road. The ca 1911 McGrath 4-over-4 window had remnants of the frame of an early small window opening in the same location.</p>

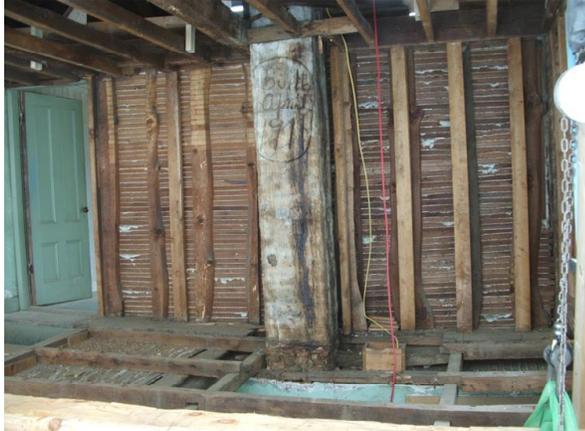
<p>During Restoration</p> <p>The NW Ell Chamber interior had the plaster removed from the ca. 1911 partition revealing an inscription on the stove chimney parging that read "Built April 1911." The floor bore evidence of the board partition about one foot behind, north of the existing 1911 partition. The ca. 1911 stair door to the left covered a sample of the early blue and yellow ochre ca. 1815 floral stripe dating to the Mary Prescott (Mrs. Peter) Barrett Period when she occupied this west dower third of the house ca. 1808 to 1846. Her inventory of 1846 includes what are likely the contents of this portion of the house. Her son Prescott would have occupied the main part of the house with his family.</p>

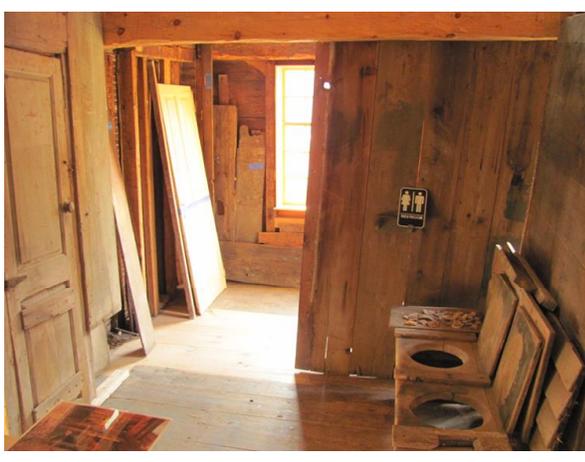
<p>After Restoration</p> <p>The original floor framing was retained and reinforced, since it was engineered originally only as eaves space under the saltbox roof. The 18th century wide pine floor was reinstalled in its original configuration. The unstable 1911 flue removed, and the old chimney opening temporarily covered to allow possible future restoration of the West Ell chimney dating to the time of Col. Barrett's rebuilding of ca. 1768. The unfinished space, that had lost its early wall and ceiling finishes in 1911, has been temporarily adapted as a display area for the original 3-hole privy and other items rescued from the McGrath wagon shed opposite where it had been moved by Patrick McGrath when the shed collapsed in 1977.</p>

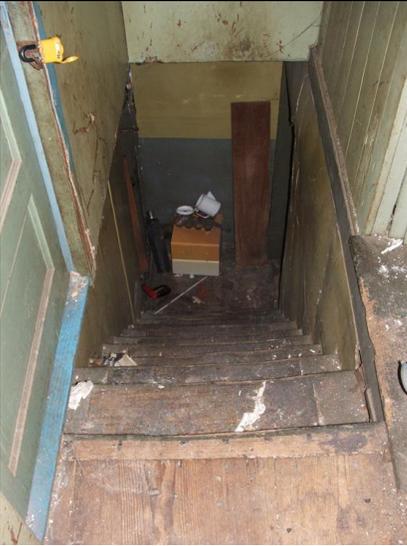
<p>Before Restoration</p> <p>The West Ell Stair as found retained all its original woodwork and plaster dating to the 18th century. The entire stair, except the landing added at the bottom, including the vertical board partition, probably dates to Col. Barrett’s rebuilding of ca. 1768. The second floor had board partitions, one seen at the right in this photo, dating to the 19th century when the second floor rear was added. The partition at the left (west) was entirely rebuilt in the 1911 remodeling by the McGraths. The early paint on the first floor partition, possibly dating to the Barrett period, was retained. The stairs were covered with old floor cloth. Plaster on the east wall was deteriorated and board partition bug infested.</p>

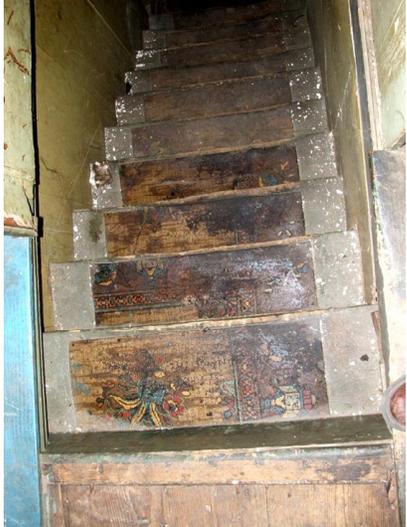
<p>During Restoration</p> <p>The re-used stair tread floor covering was cleaned to reveal a “Turkey” or oriental carpet pattern, likely dating to the Barrett period when it would have decorated a front room. The stair treads that had been weakened due to rusted nails and wear and tear, needed to be reinforced. The second floor was given a temporary handrail on the east side pending restoration of the ca. 1810s board partition that had replaced the old stud end wall of the main house. The 18th century east door from the NW Chamber of the main house to the stair had apparently been moved there in the 20th century. There may once have been another door at a stair landing near the north wall, as at the James Barrett, Jr. home.</p>
