Completion Report

Colonel James Barrett Farm

Period of Restoration - From July 2005 to December 2012

Report Date – November 2016

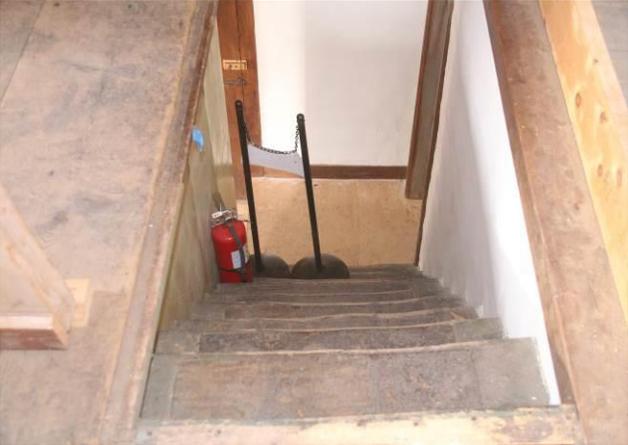
<p>After Restoration</p> <p>The original West Ell Stair, feather edged sheathing, and plasters were all preserved to reflect the time of Col. Barrett. The early paint color of the stair, a gray-blue-green, was preserved untouched and conservators treated damaged areas to match the original. Plaster on the east wall was conserved and repaired where necessary using conservation techniques. The historic floor coverings were retained in place. Stair treads were reinforced with inconspicuous blocking from below. The bottom stair landing, that had been added and rebuilt in the 20th century, was replaced, but preserved with its re-used historic floor cloth for study and exhibit. The second floor board partitions and doors remain to be restored based upon evidence found to date.</p>

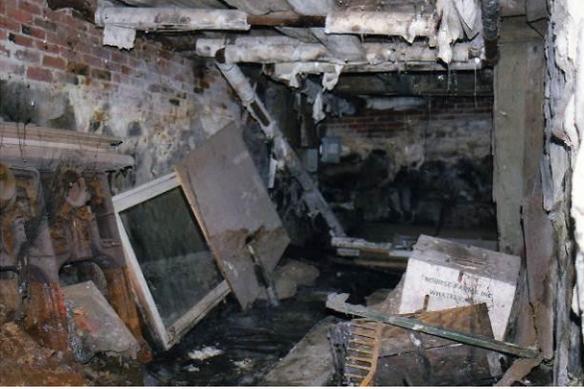
<p>Before Restoration</p> <p>The West and South Basement as found (Area 001 View South) retained early but deteriorated framing at the sills. Brick infill backed cut granite underpinning added in the first quarter of the 19th century. However, the original rough dry-laid fieldstone foundation remained below. On the floor, the edge of a raised stone platform could be discerned under layers of silt outwash from the exterior walls. The framing of the first floor west remained. However, it had been rebuilt in the 19th to 20th century duplicating its 18th century appearance and configuration. Exterior windows had also been replaced in the 20th century and were beyond their useful life, although the openings were in their presumed original locations, in the cut stone underpinning.</p>

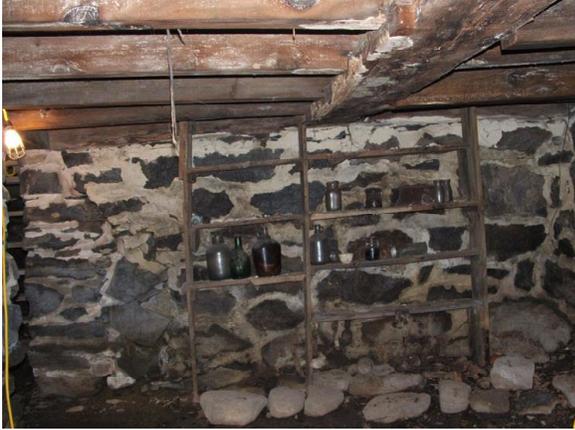
<p>During Restoration</p> <p>The original framing (Area 001 View North) had to be repaired at the perimeter and the foundation re-pointed above grade. However, the old shelving for preserves dating from at least the early 20th century was retained in place along with early 20th century preserves of the McGrath family. The grade was lowered to the original level to allow proper drainage and additional headroom. The glacial cobbles used for keeping food storage barrels above water level were retained in place. On the floor above, floorboards that had buckled due to humidity rising from below were flattened and re-nailed. The area was re-graded to allow water to drain to a sump in the north cellar.</p>

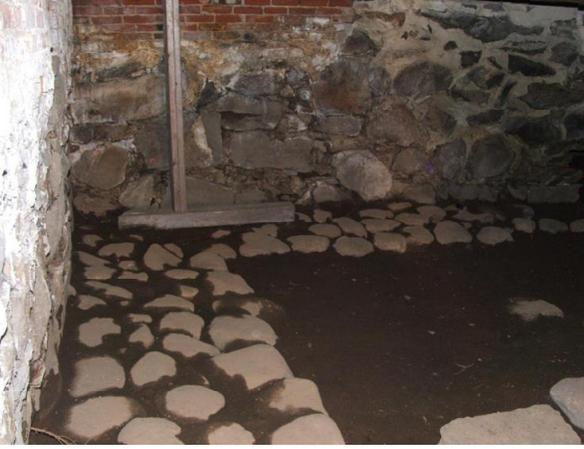
<p>After Restoration</p> <p>In the final restoration (Area 001 View West) early cobble food storage platforms that would originally have held food storage barrels for root vegetables such as potatoes and carrots or orchard products like apples, were excavated with archaeological oversight to reveal the original stonework. The earth floor was lowered for drainage and to expose the edge of the stone platforms as they would have appeared in the time of Col. Barrett. Brickwork was re-pointed as necessary around the window openings that received new reproduction wood windows with Spanish Cedar frames (for water resistance) and details typical of the period of Col. Barrett.</p>

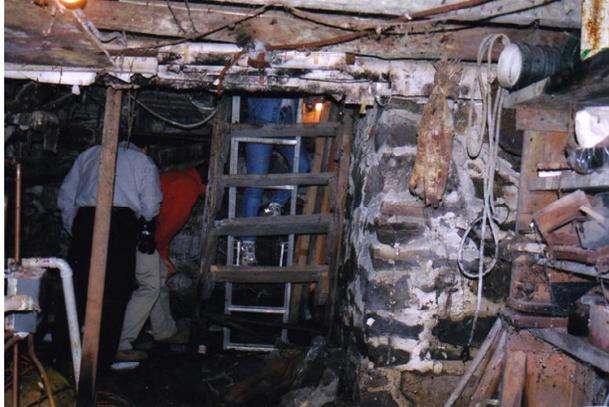
<p>Before Restoration</p> <p>The East and North Cellar as found (Area 003 View North) retained its original wood framing and sub-floor beneath the Muster Room. It had severe water infiltration and many later accretions such as electrical wiring and pipes with asbestos insulation. Some 20th century shelving held McGrath-era items that remained in place. The cellar stairs were decayed and moisture damaged to the point of near collapse. An old steam boiler sat on a concrete pad and water rose to a level of a couple of feet upon occasion. Despite all this the original framing was sound enough to retain with reinforcement in the east cellar, but it had to be replaced due to severe decay on the north (004).</p>

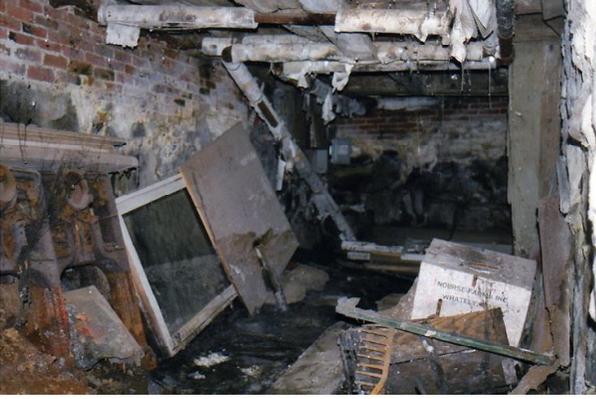
<p>Before Restoration</p> <p>The South and West basements as found (Areas 001-002 View West) as elsewhere, were filled with hazardous materials such as oily water, asbestos-insulated steam heating pipes, as well as festooned with outdated and unserviceable electrical equipment and wiring. The large accumulation of debris made it necessary to remove most of the contents to meet safety and health codes. Areas of framing under the front and West Ell stair (area 010) needed minor reinforcement. The original floor surface was buried under silt outwash from the old dry-laid foundation walls. Old features such as shelving and a cultivator of the McGrath era were not removed.</p>

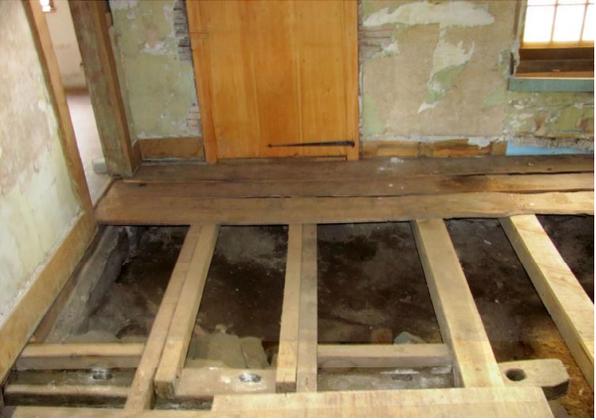
<p>During Restoration</p> <p>The West Ell had a crawl space under areas 007 and 008. This photo (Area 008 View South) shows original framing resting on a re-used framing component, an apparent post (foreground) with four elongated holes. This could also have been a fence or gate post, or alternatively, due to its slight upward curve at one end, an 18th century stone boat runner such as would have been used to haul stones, firewood, or other heavy items (such as ordnance). This component was left in place rather than removed for exhibit as it supported the rest of the first floor framing. The crawl space below exhibited the lime-mortared exterior of the original main house that had been initially pointed above grade and to a point below to deter rodents.</p>

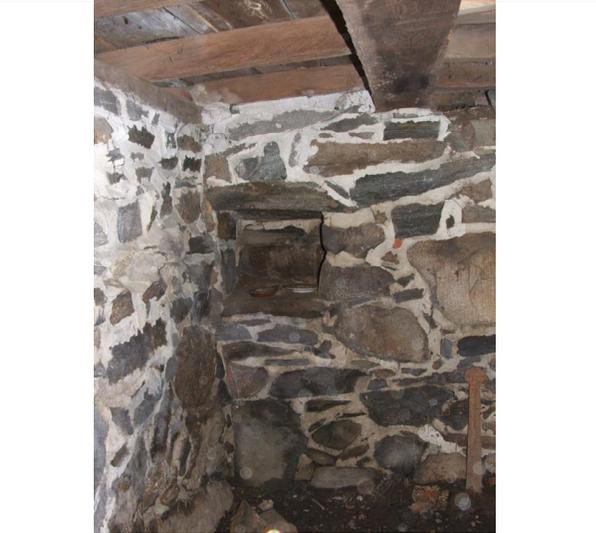
<p>After Restoration</p> <p>The cellar area (010 View West) of the West Ell retains its stone niche undisturbed, along with lime mortar infill that was done prior to the restoration. Most areas of the cellar were left undisturbed, except the perimeter walls above grade, and the northeast corner of the chimney base. The West Ell cellar stair, like that on the northeast leading to the kitchen, had to be rebuilt. However, these stairs were not original; they were badly decayed and insect infested and were photographed for documentation purposes. The only changes to this part of the cellar involved repair and replacement of the 1st floor wide pine boards above.</p>

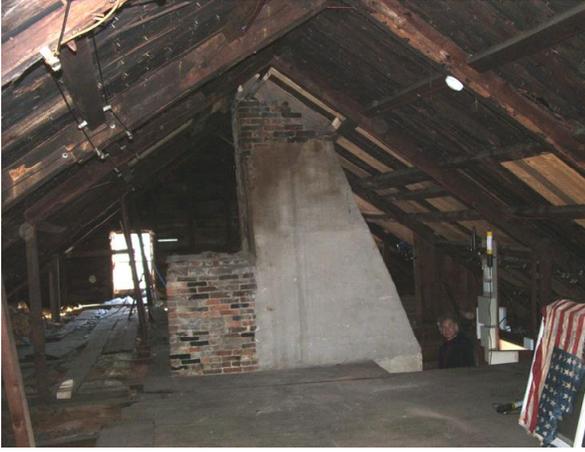
<p>Before Restoration</p> <p>The West Attic (Area 301 View East) as found retained most original framing and flooring dating to the 18th century. The front rafters had been doubled in length at the time of the addition of the second floor rear in the ca.1810s. At that time, the rear saltbox rafters had been raised up and several formed the rafters of the raised rear roof slope. The chimney top through the roof had been rebuilt in the 19th century down to the area where a brick smoke chamber had been added at the time the rear roof was raised. Later parging covers most of the brickwork of the chimney; however, it appeared to be original to the period of Col. Barrett from the top of the smoke chamber down.</p>

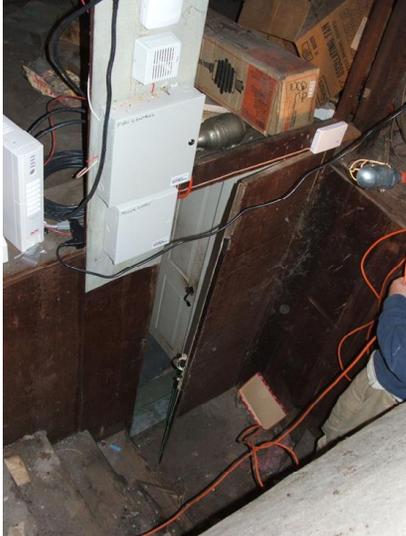
<p>During Restoration</p> <p>The attic stair (Area 302 View SW) was entirely original including the two runs of steps to the east and west parts of the attic, needed in the original saltbox due to low headroom at the rear and the center chimney preventing access between the east and west attics. No carpentry was necessary on the stair; however, the unique bi-fold door, dating to the 18th century, was split. This needed to be glued, but the door was otherwise all original including its wrought iron hardware and painted surfaces. Necessary alarm and temporary electrical systems were installed at the front under the roof eaves.</p>

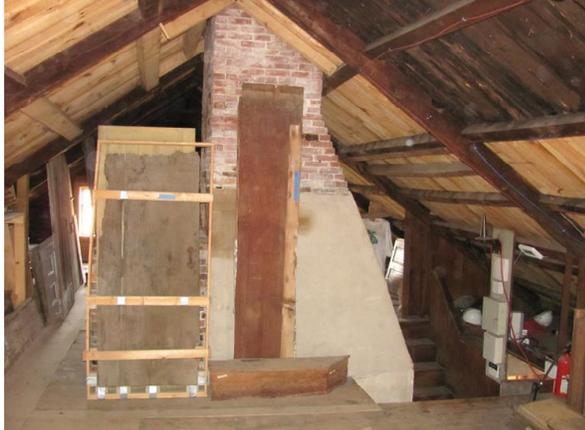
<p>After Restoration</p> <p>The West Attic (Area 301 View East) had the upper portion of the chimney rebuilt to its appearance dating to the time of Col. Barrett. The roof retained most original framing except those components deemed by engineers too deteriorated to support required snow and wind loads. These components were replaced with materials and approximate sizes matching the originals. The original purlins that had to be removed were stored in the attic for study and future exhibit. The roof sheathing boards that had severely deteriorated or were insect infested were replaced in kind, and samples salvaged and stored for study. Sound sheathing was retained. The south-side floor required only minor patching for safety of visitors and artifact storage. A floor was added on the north-side for safety and to protect the ceiling below. The north-west floor area was left open to allow viewing the attic from below.</p>

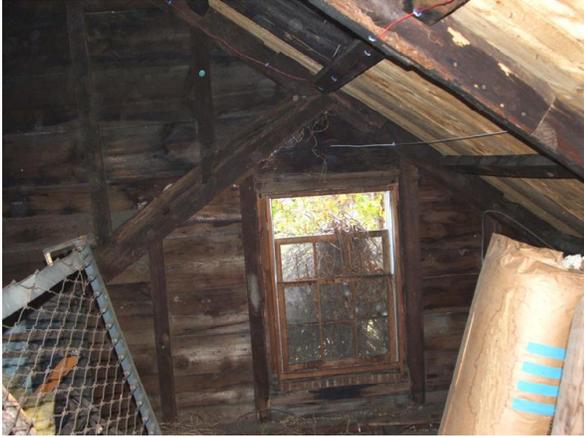
<p>Before Restoration</p> <p>The East Attic as found (Area 303 View East) retained all its original framing dating to the 18th century. The front rafters and purlins likely date to Col. Barrett's rebuilding of ca. 1768 if not before. The End wall sheathing in the original gable was mostly original, and that of the rear addition dated for the most part to the ca. 1810s. The original roofline of the old saltbox is visible in the end gable. The ca. 1810s window opening retained fragments of the original molded plank window frame at the top. The ca. 1910's McGrath era 6-over-6 sash had replaced the ca. 1810s 3-over-6 seen in early photos. The open window had bittersweet and other invasives creeping into the attic. Some front roof sheathing had been replaced earlier, probably in the 1970s.</p>

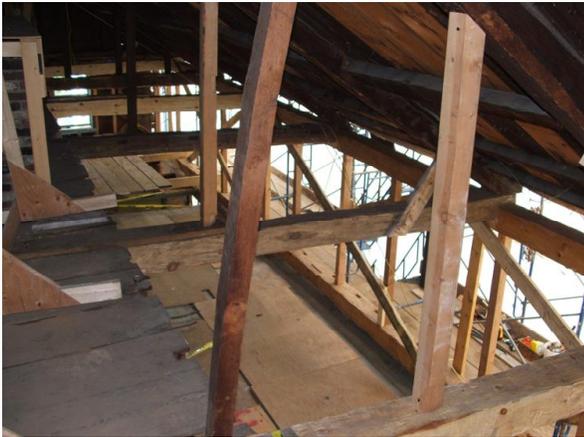
<p>During Restoration</p> <p>The north rear portion (Areas 304-306, View NW) of the attic framing had been added in the ca. 1810s, but had deteriorated and been replaced by modern framing, likely in the 1970s. The joist pockets and some remaining joists and girts allowed exact reproduction of the missing and damaged pine framing and sheathing. Struts had been added in the ca. 1810s when the roof was raised at the rear to two stories, and missing or damaged struts were repaired and/or replaced as required to meet engineers' requirements for wind and code-allowed roof and floor loads. Floor joists were re-installed at old locations and wide pine floorboards matching original were then installed.</p>

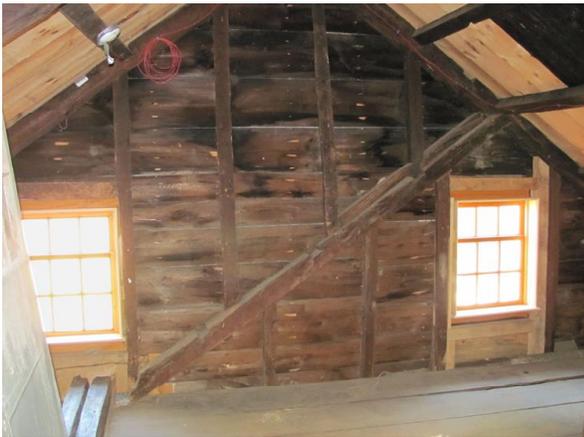
<p>After Restoration</p> <p>The East gable (Area 202 View East) retained all early sheathing dating to the time of Col. Barrett and the ca. 1810s rear addition. Original plank window frames and 3-over-6 sash were fabricated to exactly match the originals and re-installed with new pine sheathing to infill the areas cut out for larger later window openings. The original floor was left undisturbed but one board lifted to reveal the planed underside of the floorboards and the 18th century plaster ceiling of the 2nd floor below. Joists had also been planed and chamfered indicating the framing below was originally exposed in the ca. 1705 original home when Col. Barrett was born there in 1710.</p>

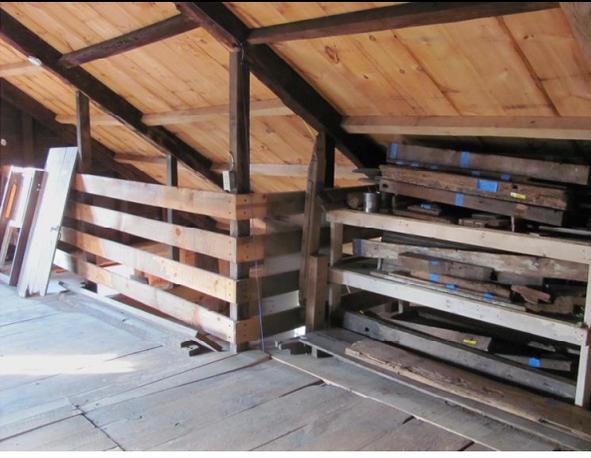
<p>After Restoration</p> <p>The West Ell Attic’s northwest corner (Area 307 View NW) retained no trace of any attic level floor or framing. It was therefore left open with a wooden board railing built for safety of occupants. Most original rear rafters were retained, along with sound purlins. The unsound purlins and sheathing had to be replaced to meet wind and snow load requirements. The north eaves area adjacent was used for storage with the addition of movable wooden storage shelves. Large fragments of 18th and 19th century Barrett period fragments from the house deemed unusable in situ were labeled and stored here for future study and potential display.</p>

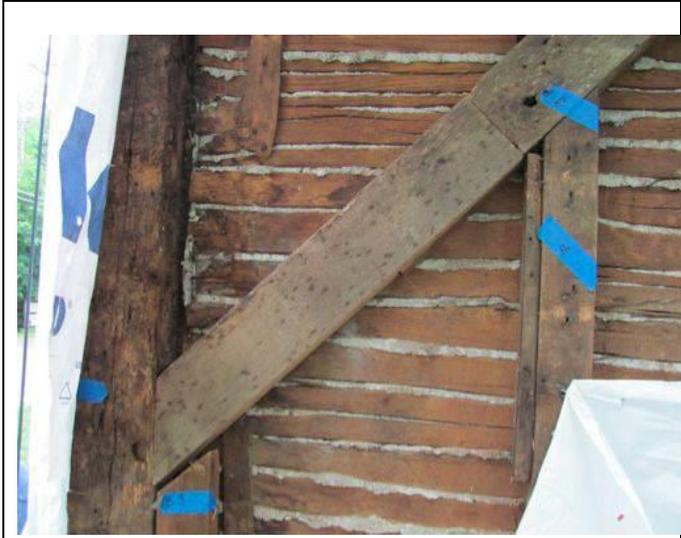
Figure 20 The Southeast Post
After new piece was put in place.

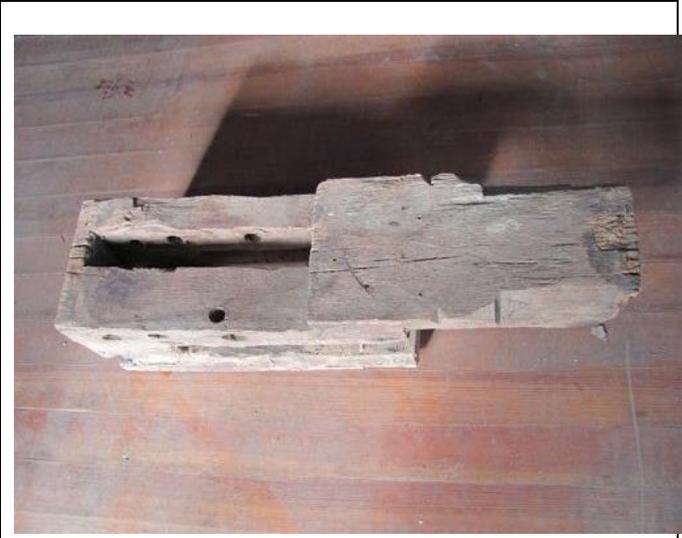
Figure 21 First Period 17th century NE Post
Re-used by Col. Barrett in his ca. 1768 rebuilding.

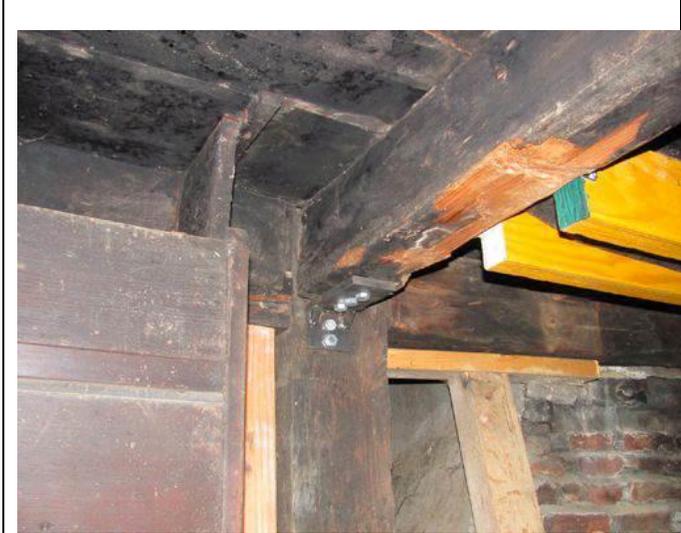
Figure 22 Kitchen Joists
Some inconspicuous steel and sistered joist reinforcement was installed under wood casing.

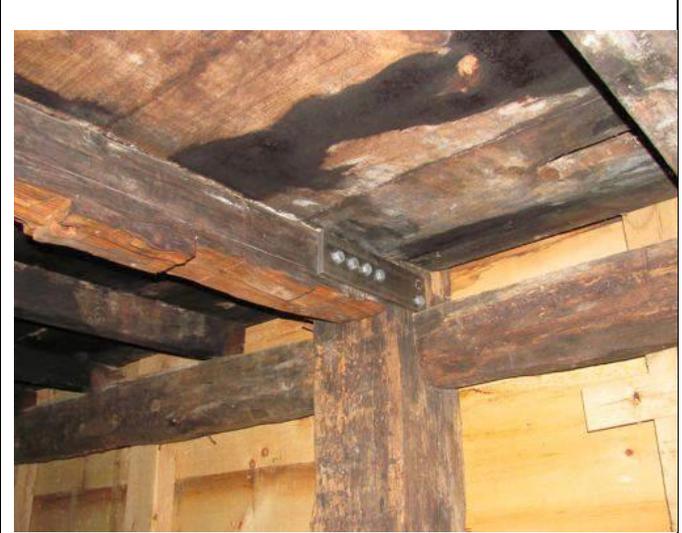
Figure 23 Kitchen Steel Reinforcement
Some necessary ties were installed in the kitchen, later covered by wood casing as it had been.

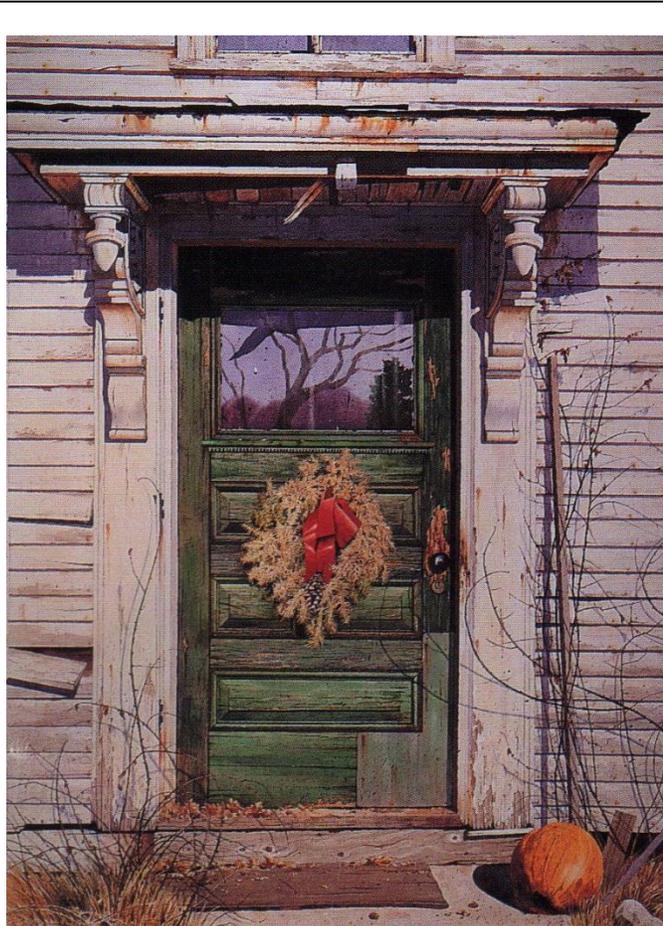
Figure 30 Front Door – Before Restoration

Severely deteriorated and historically inappropriate 20th century exterior doorways were salvaged and stored. New reproduction doorways were fabricated by North Bennet Street School of Boston and Arlington. The Front door is based upon the shadow of the original found on sheathing below later clapboards and trim. It duplicates the Old Manse West doorway of ca. 1770 that matched the silhouette as well as the details of the fluted pilasters and trim in the Barrett Parlor. The West Ell Doorway was reproduced to match the original seen in historic photos with transom bulls-eye panes similar to the originals at the Concord Museum. The rear and East Entry doorways were based upon the historic 1880s photo of the kitchen door as well as the door itself found at the Medford Historical Society and now at the Concord Museum.

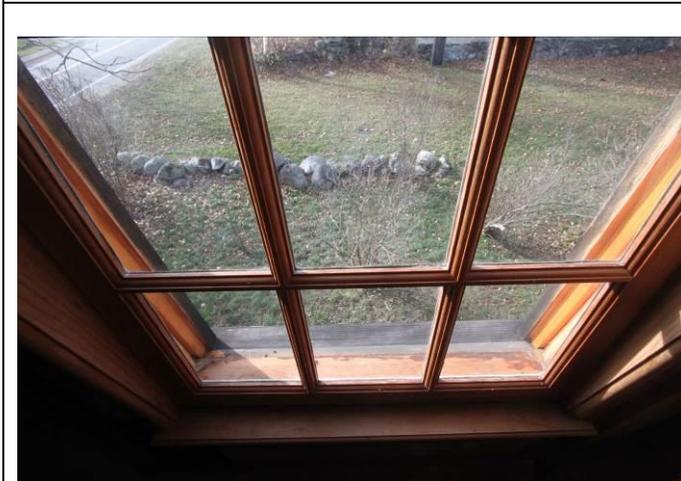
Figure 34 NW Window out of Groove

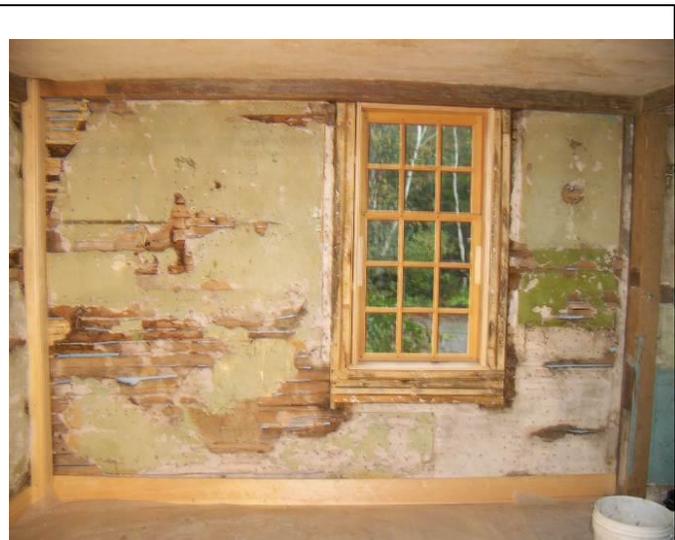
Figure 39 Plaster - Rear West Ell - West wall
After adhesive injection

There were a few places where the plaster was intact but large sections were floating free of the lath. This was found in the Parlor Chamber on the east wall in the area south of the fireplace and the south and west walls of the West Ell Parlor. For these areas the adhesive was injected in a grid pattern every 4 to 6 inches throughout the area of hanging plaster.

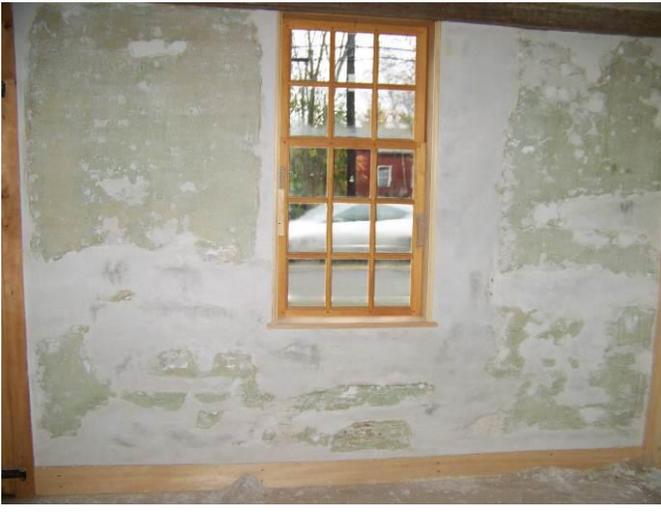
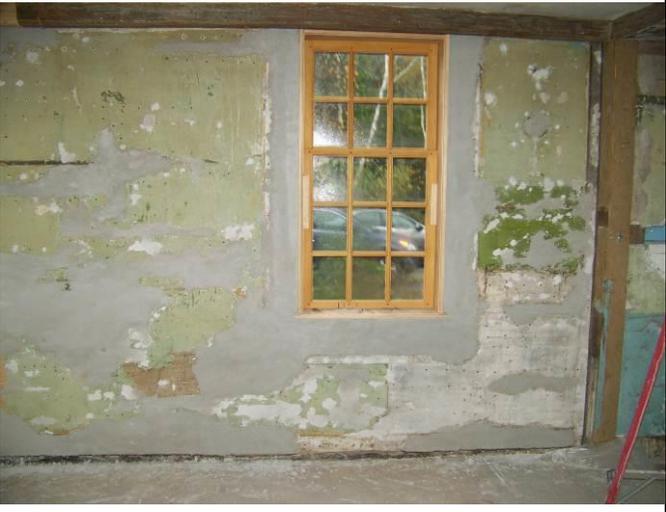
<p>Figure 40 Plaster – West Ell - South wall After plaster patching</p>	<p>Figure 41 Plaster - Rear West Ell - West wall After plaster patching</p>

There were areas of missing plaster where the larger Victorian windows had been removed to go back to the 18th century size windows. There were also various sized holes in plaster surfaces throughout the house. There were large sections of missing plaster on the south and west walls of the west ell parlor. The plaster was removed on the north wall of the West Ell Parlor, the south wall of the West Ell back room and the area below the window of the west wall of the West Ell back room. This last area was filled in with a horizontal wainscot. The other areas of missing plaster were redone with a three coat plaster system. The scratch and brown coats were done with a mix of 3-parts sand to 1-part lime and hemp used as a fiber. The finish coat was a mix of 1-part sand to 1-part lime. A setting type joint compound was used to even out transitions between patched and old plaster.

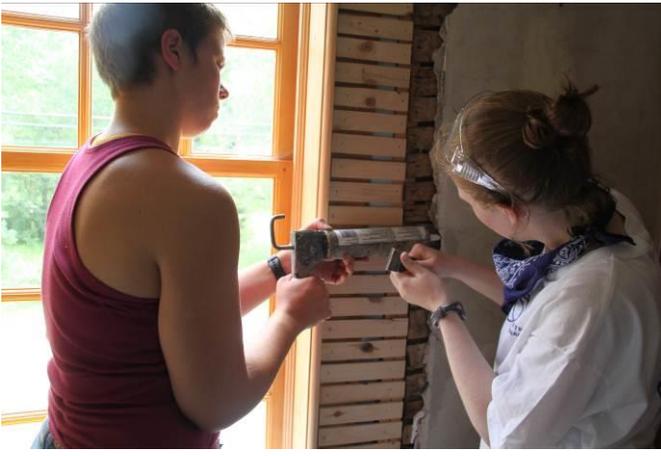
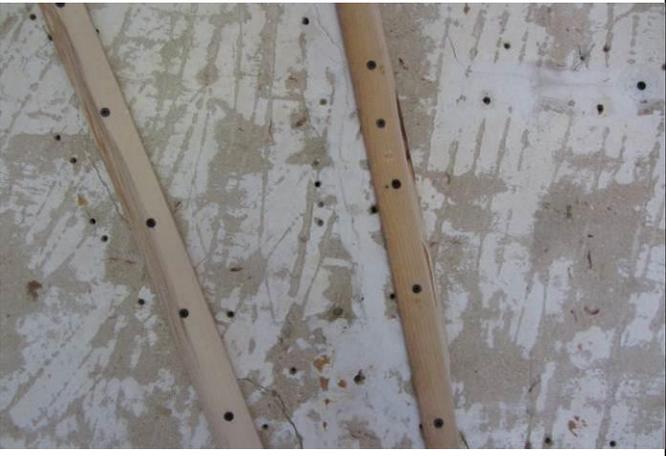
<p>Figure 42 Injecting epoxy behind old lath To hold plaster</p>	<p>Figure 43 Straps hold plaster while epoxy dries</p>

Big Wally’s plaster adhesive was used to reattach plaster to lath. This was done along the length of cracks by drilling 3/16th on either side of cracks every 3 – 4 inches along the length of the crack. This was then temporarily clamped to pull the lath to the plaster. After the adhesive had set the clamps were removed. The injection holes were filled with a setting type joint compound. A similar procedure was followed around the perimeter of areas of missing plaster.

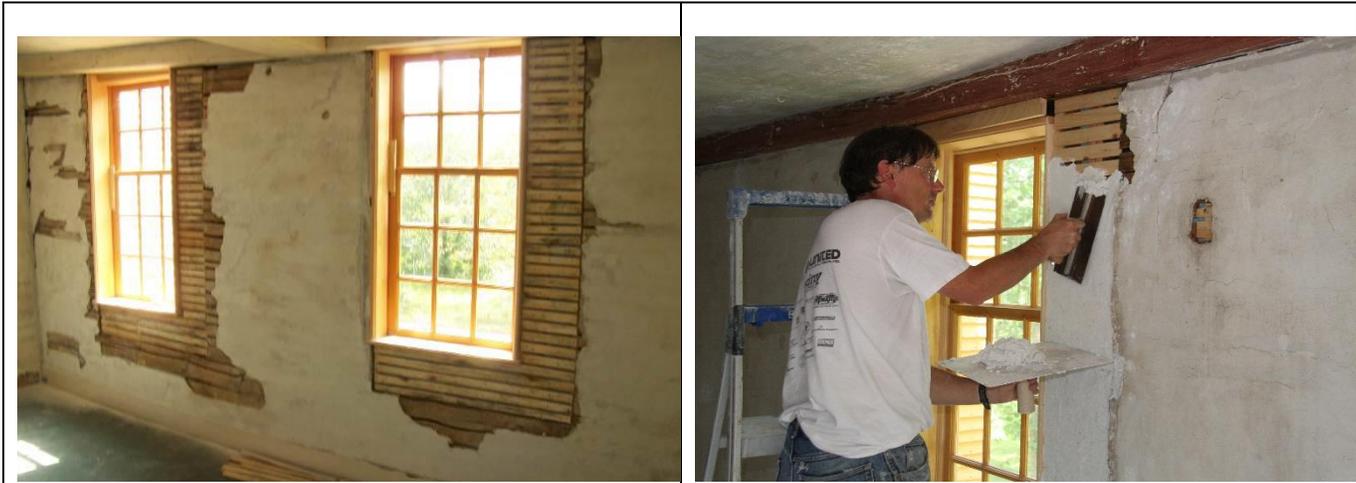
Figure 44 Typical area around windows
With new lath inserted

Figure 45 Plastering over the new and old lath

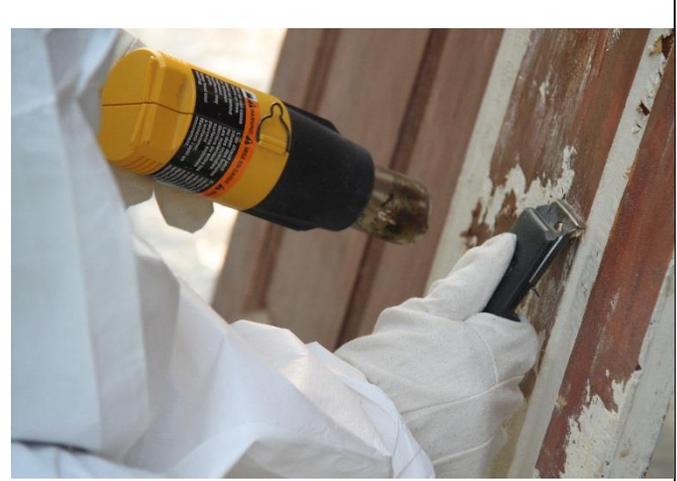
Figure 51 Removing later paint layers
Used low-temperature heat guns to soften paint

Flaking and peeling interior lead paint layers were, with the consultation of the NPS, agreed upon to be removed from the underlying historic paint layers. Small patches in various locations retain the entire paint sequence as well as samples collected by both the NPS and John B. Vaughan of Architectural Conservation Services in Bristol, RI, for future study. The lead remediation team from Alpine Environmental developed appropriate procedures using infrared heat sources to remove the overlying paint to expose the original and/or early painted surfaces. Some decorative marbling of fireplace bolection surround, firebox plaster parging, and cedar graining of interior woodwork with mahogany grained mopboards was revealed. All historic paint surfaces were preserved as much as possible and conserved by Marylou Davis, conservator and a team of Smith College interns, completed in 2012 by Bridget Byrne, Wenda Kochanowski, and Catherine Lipscomb. This makes the Barrett Farm one of only a handful of historic 18th century buildings in the entire country that retain their original decorative paint on display. Details are discussed in the paint studies.

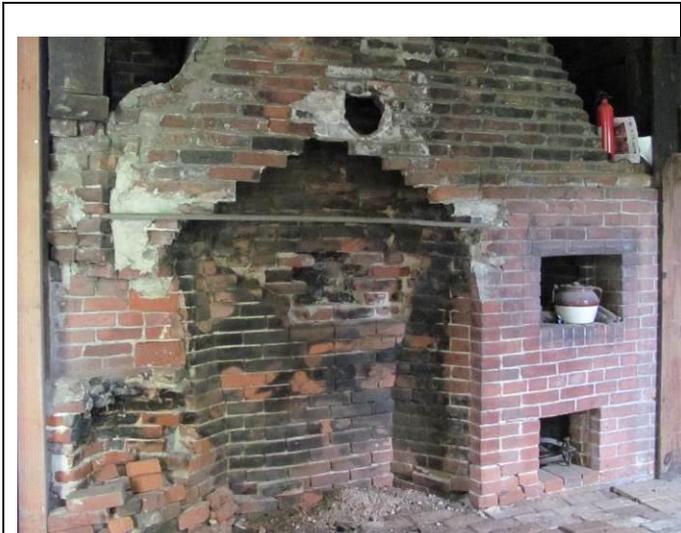
Figure 60 Kitchen Fireplace – Before Restoration

The firebox of the kitchen fireplace had been reduced in size in the early 1800s when the oven was re-built, then later severely damaged in 1970s renovations.

- a. The kitchen fireplace firebox was rebuilt to match the surviving remnant of the east jamb that also preserved the original lintel height and line of the back wall of the firebox. The smoke chamber of the fireplace had to be repaired and a new cast iron damper was installed to allow potential use of the fireplace. The early 1800s rebuilt brick oven and smoke chamber were preserved intact with minimal work done to them except to repair the interior oven flue.

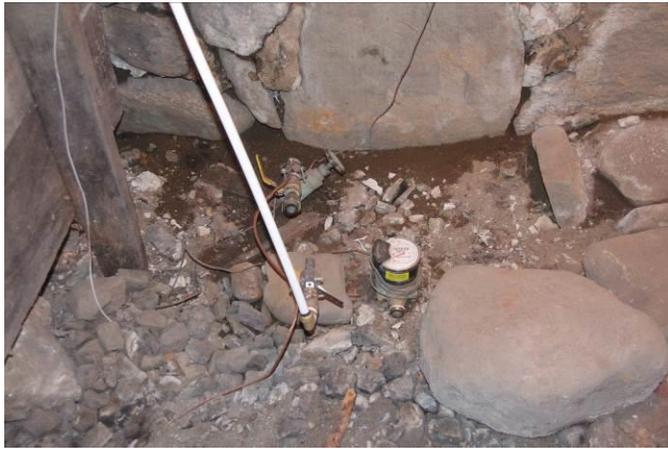
Figure 86 Water Meter – Basement
Disconnected during winter season

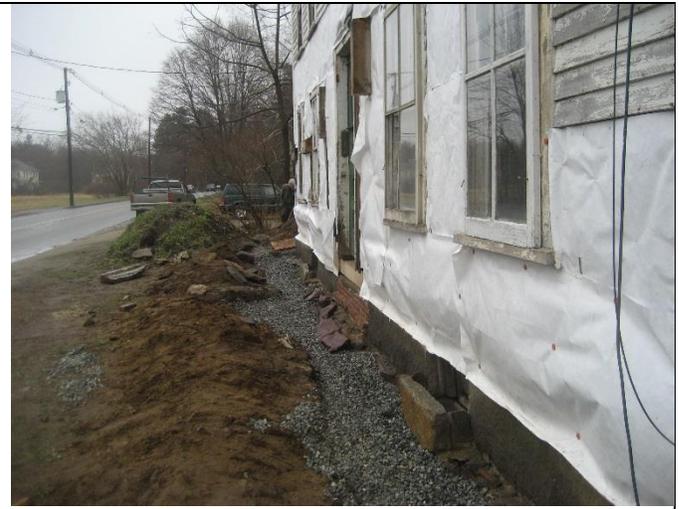
Figure 112 Drainage Ditch from Manhole to Street

A new drainage system of pipes was installed in 2012 on the site of the previous drainage ditch shown in old photos. It was engineered along with the Town Engineering Department and with Natural Resources Commission approval. This drainage system is expected to mitigate the serious flooding of the property that occurred annually during the wet seasons. A sump pump now provides drainage for the house that was seriously and adversely affected by water infiltration over the years. The drainage work was done under Massachusetts DEP File # 137-1109. Drainage details are in the Drawings Completion Report.

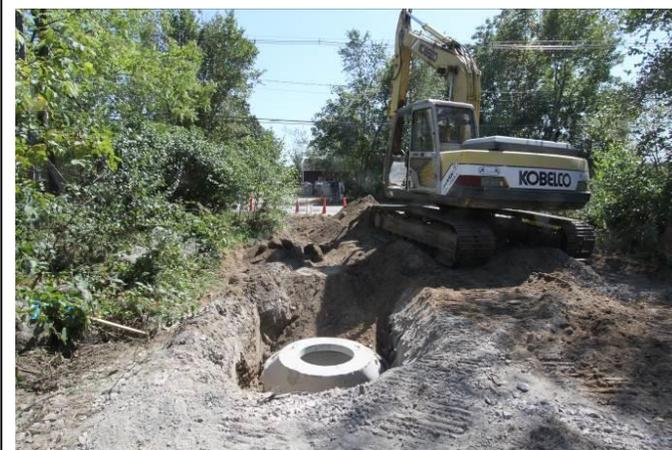
Figure 113 Drainage in Rear of House

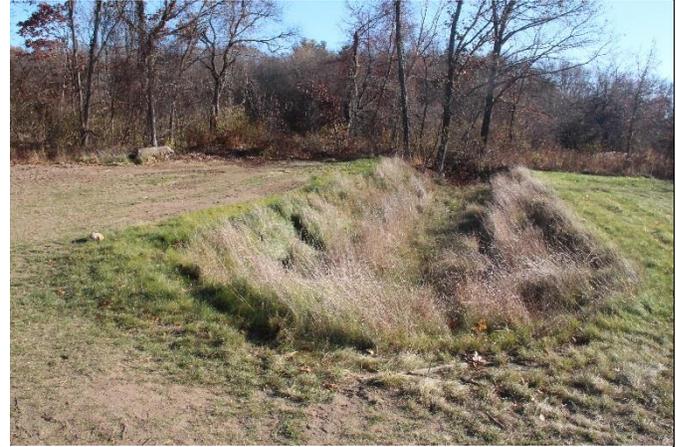
Figure 117 Drain Outlet Ditch 2013

The cesspool to the north of the kitchen, likely installed in the 1930s, was removed as part of the drainage upgrade. The cesspool outlet was found to be connected to the drainage ditch. The drainage ditch behind the house and the buried utilities were passed through the cesspool piping path so as to maximize the use of previously disturbed soil and minimize the impact on future archaeological digs.

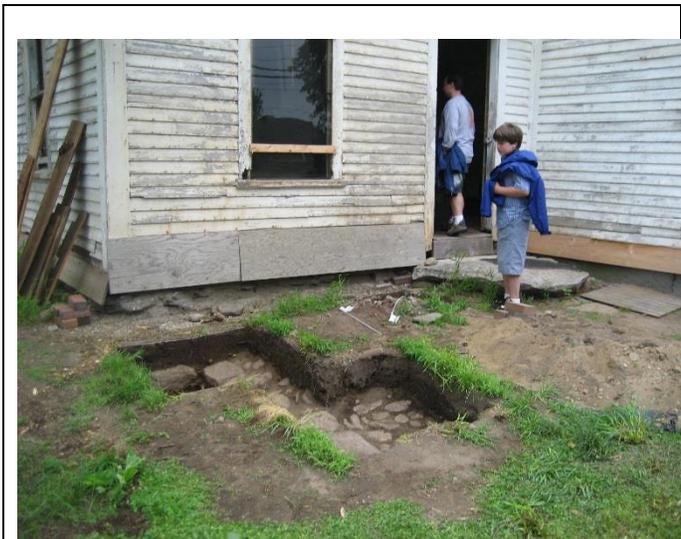
Figure 118 Cobble in Front of West Ell

Cobble paving is visible at the southeast corner of the house in early photos. These and others were revealed by archaeological digs documented in archaeological reports by the University of Massachusetts (bound separately). The principal areas where the cobble paving was found were a) in front of the west entry b) below the east entry Cheese Room or Dairy (a typical feature) c) in front of the West Ell entry, and behind the West Ell and along the rear terrace of the house. A separate flagstone path to the front door was also uncovered in the course of work and remains exposed. These areas have all been preserved as much as possible in situ, and restored where disturbed in the course of rebuilding the East Ell Entry foundation.

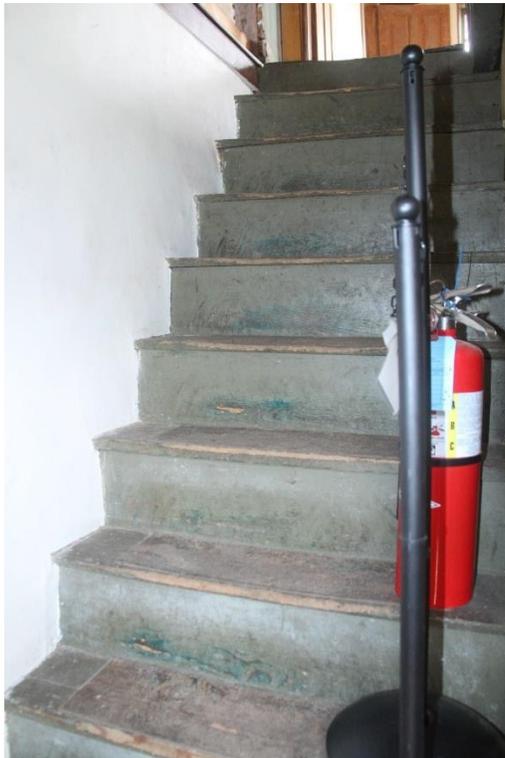
Figure 121 West Ell Staircase

The West Ell rear staircase provides a second exit from the upper floor. Its steps are narrow and there is currently no hand-rail or adequate protection at the second-floor level. There are drawings for fixing this situation. There is a wall stored on the second-floor West Ell that could be re-installed. Check Col. James Barrett's son's house (at the corner with College Road) for a similar layout.
